# Failure Analysis Report

FA QEM-CCR-1907-01258

| <b>Device Type:</b> | TPS25200DRVR | <b>TI Contact:</b> | Wendy Huang |

| Summary | |
|---|---|
| TI Failure Description | Unit#1-#2: pin1 (OUT) and pin6 (IN) short to pin5 (GND). |

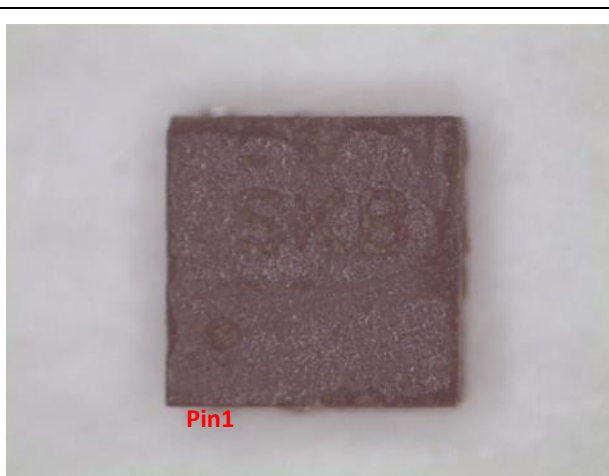
Figure 1. Unit#1.  
Optical image of the top of the device.  
No anomaly was observed.

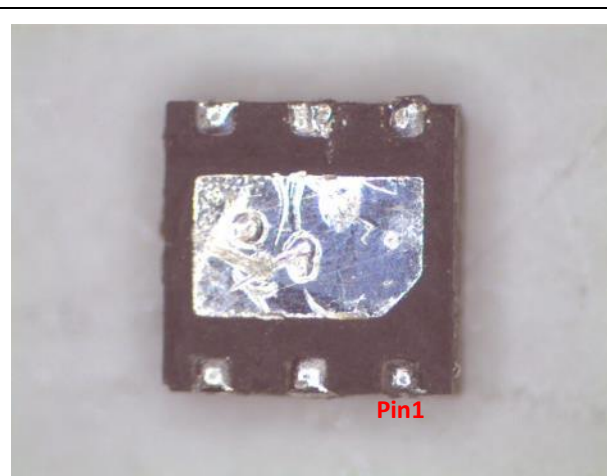
Figure 2. Unit#1.  
Optical image of the bottom of the device.  
No anomaly was observed.

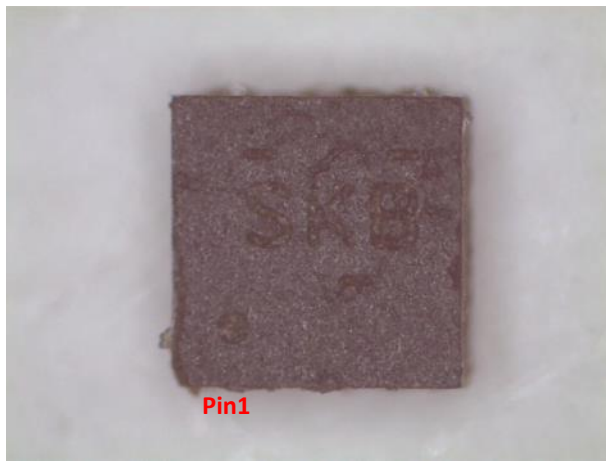
Figure 3. Unit#2.

Optical image of the top of the device.

No anomaly was observed.

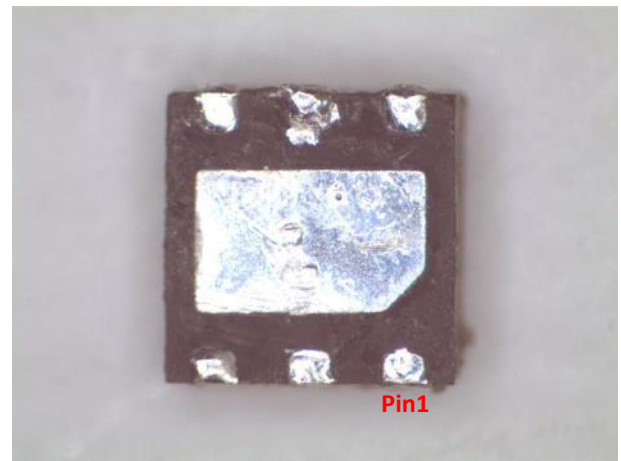
Figure 4. Unit#2.

Optical image of the bottom of the device.

No anomaly was observed.

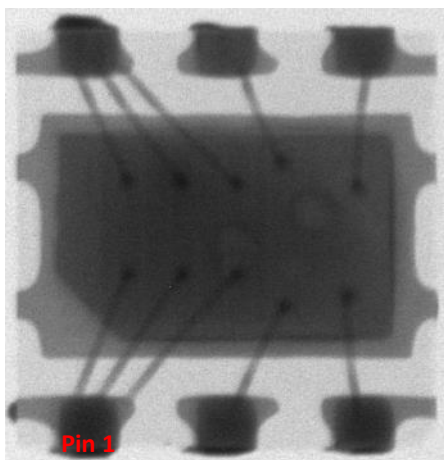
Figure 5. Unit#1.

Top view X-ray image of the device.

No anomaly was observed.

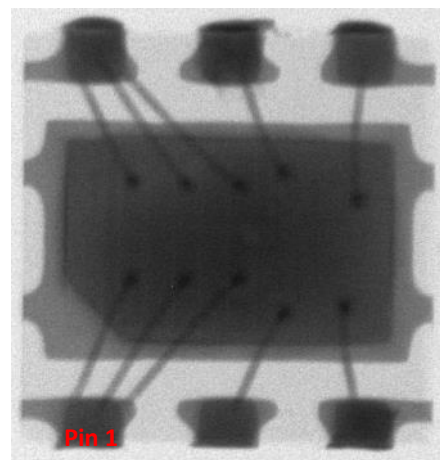
Figure 6. Unit#2.

Top view X-ray image of the device.

No anomaly was observed.

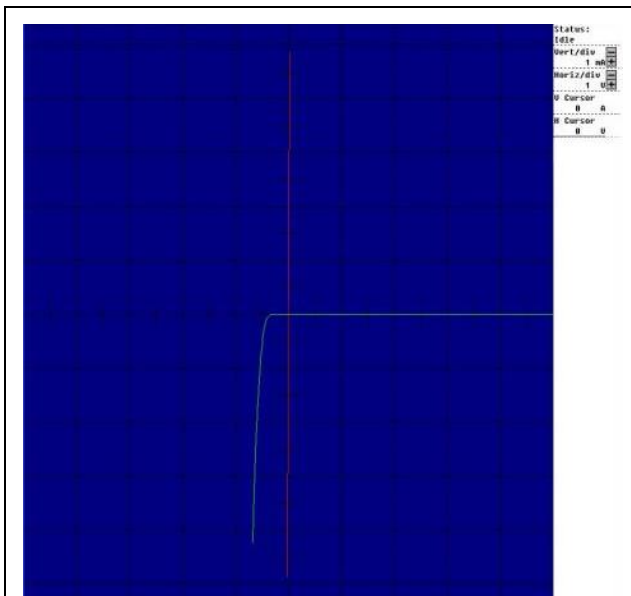
Figure 7. Unit#1.

IV curve revealed pin1 shorted to pin5 (GND).

The green curve indicated a correlation unit.

This image represents unit#2, too.

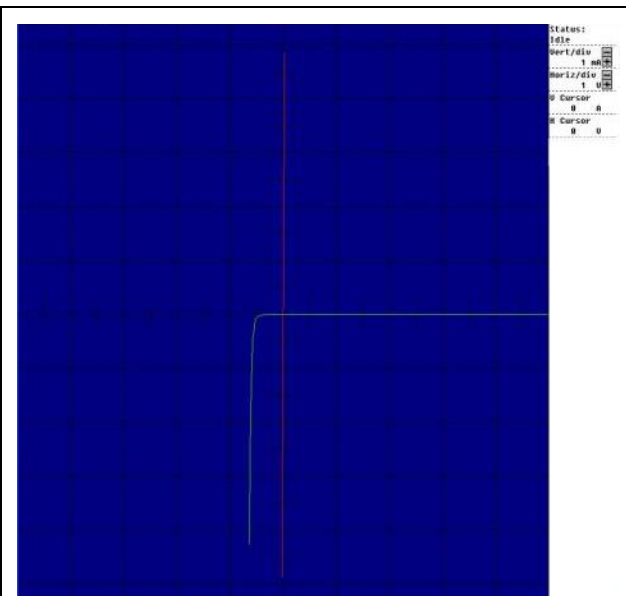
Figure 8. Unit#2.

IV curve revealed pin6 shorted to pin5 (GND).

The green curve indicated a correlation unit.

This image represents unit#2, too.

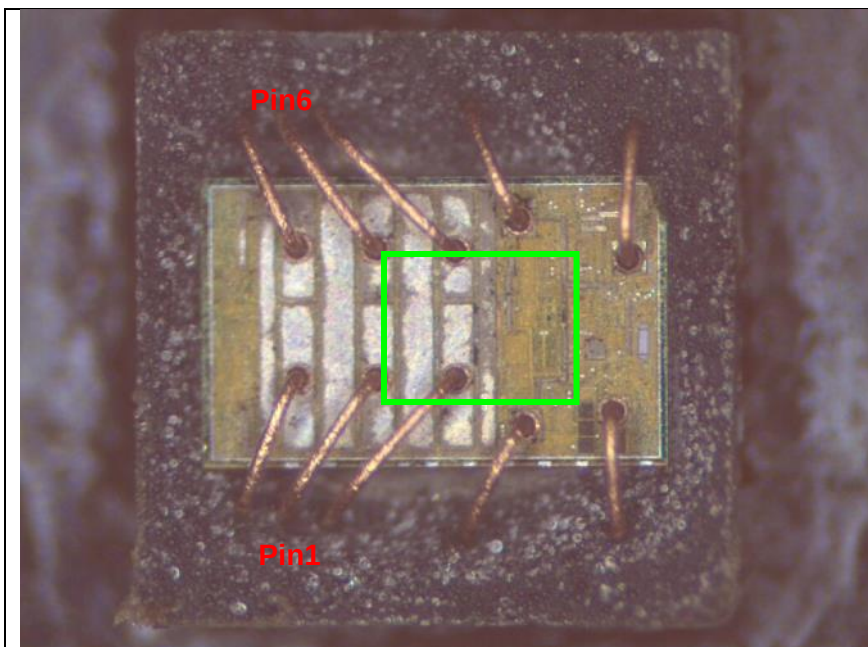
Figure 9: Unit#1.

Optical inspection of the de-capsulated unit#1 revealed Electrically Induced Physical Damage (EIPD) in the form of burnt out damage and fused metallization were observed.

Optical image of the die overview after de-capsulation.

Electrically Induced Physical Damage (EIPD) was observed in the green box.

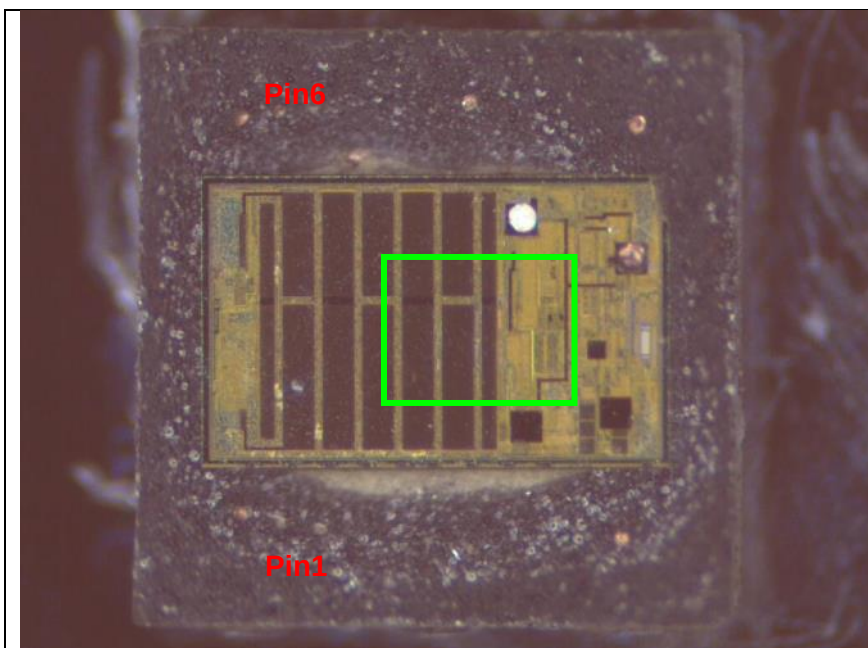
Figure 10: Unit#1.

The same area as in figure 9 after bonding wire, BOAC removal.

Electrically Induced Physical Damage (EIPD) was observed in the green box.

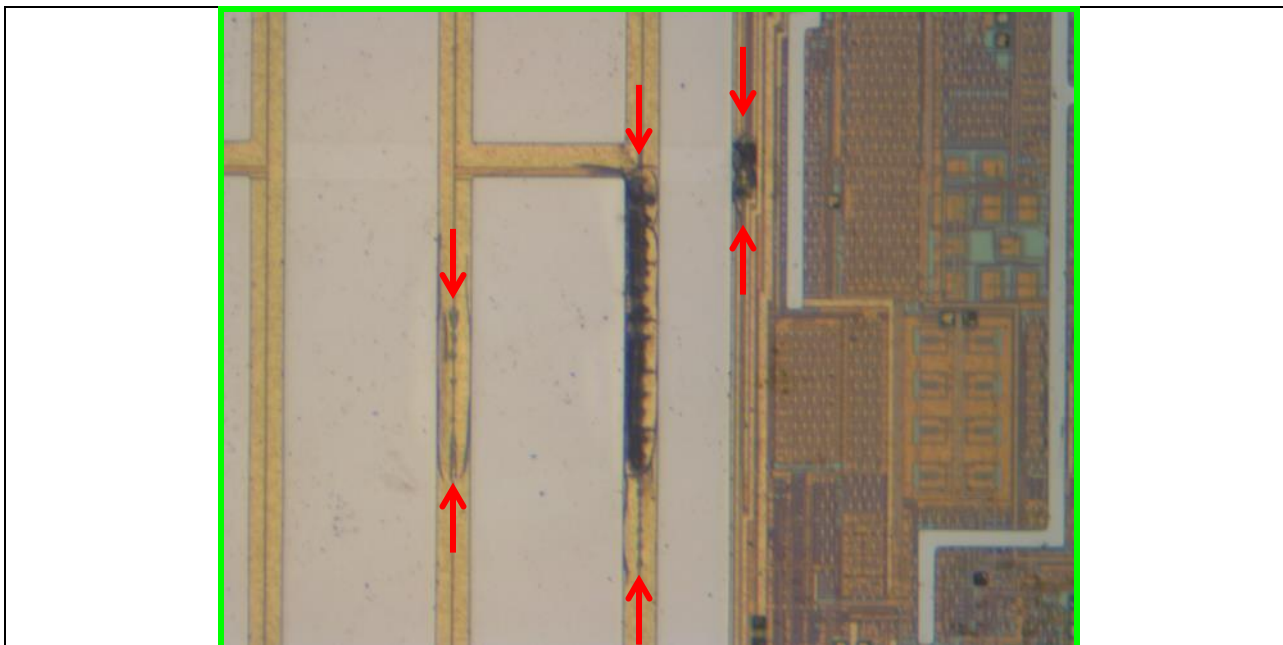
Figure 11: Unit#1.

Zoom in view of green box in figure 10.

Burnt out damage and fused metallization were observed, indicated by the red arrows.

Electrically Induced Physical Damage (EIPD) in the form of burnt out damage and fused metallization were observed on unit#1.

Unit#1 failed due to the Electrically Induced Physical Damage (EIPD) observed.
