# BFX-AT100 Control Run

## New SW and Motorcomm 2<sup>nd</sup> source

Prepared by: PE- Nam

# New FW & 2nd Source Control Run Report

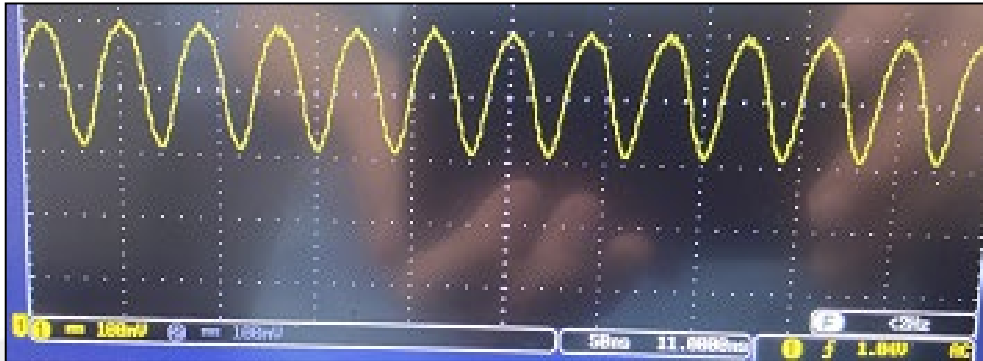
Main Source value = 25Mhz, Meet spec

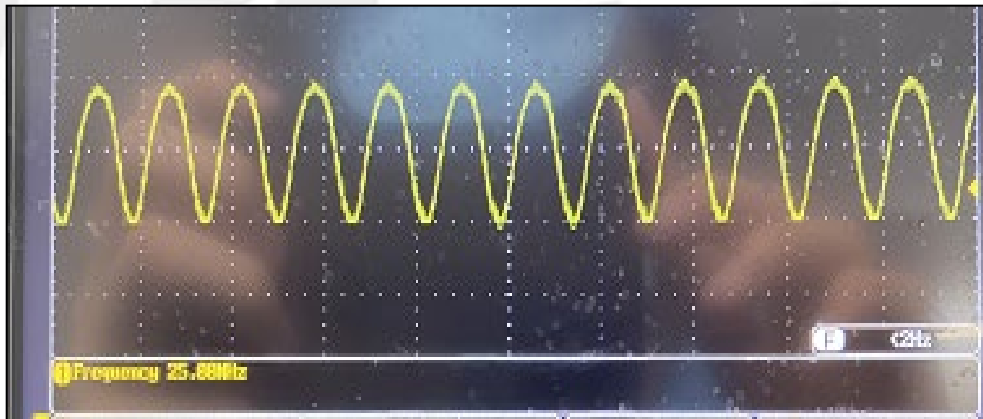
2nd Source value = 25Mhz, Meet spec

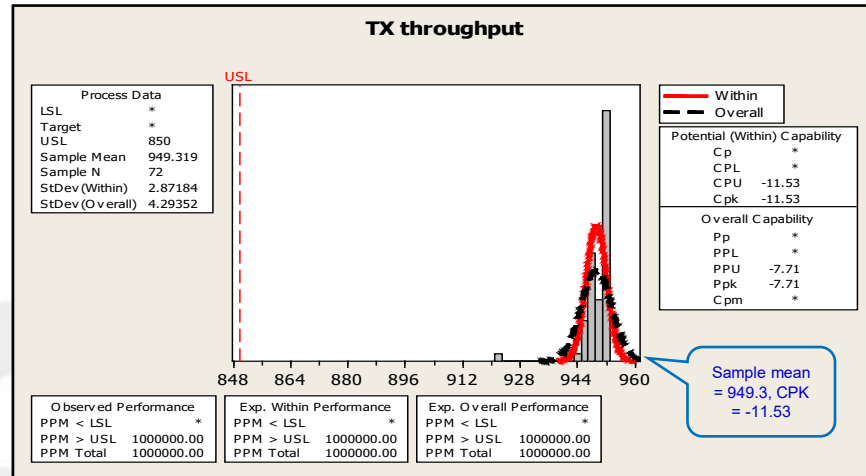
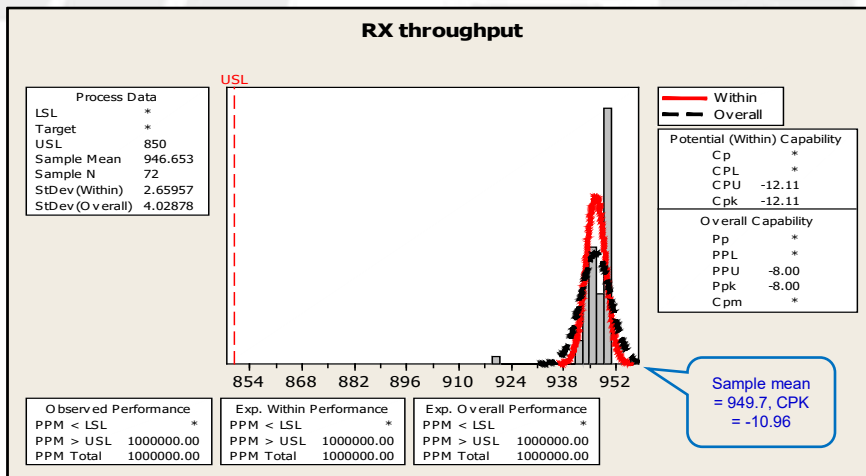
## Main Source and Old SW

**Summary:** The CPK data between Main Source and 2nd Source are not difference and value
