# T99X171 SKBB OTT box

Sample issues

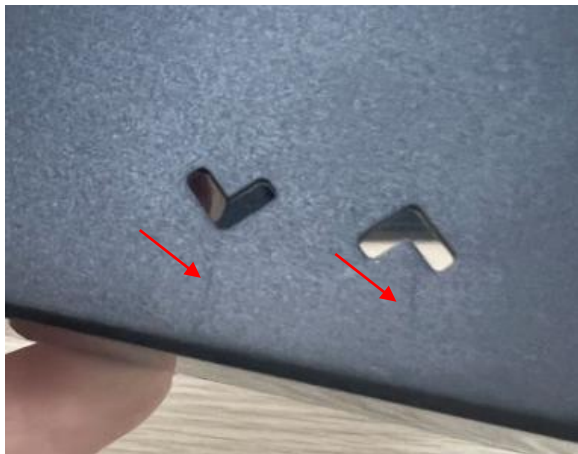
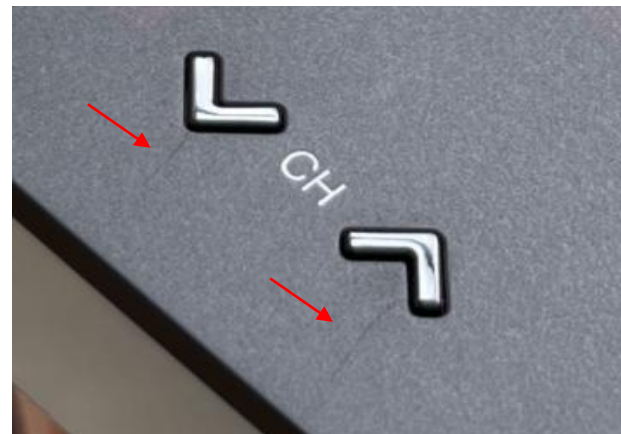
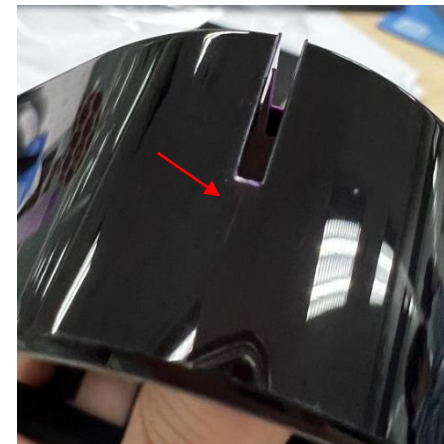
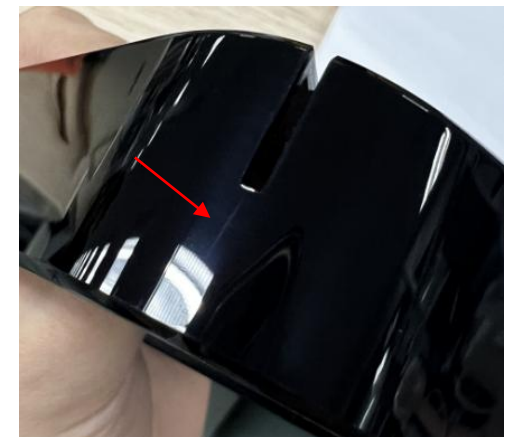
**Issue 1:** Welding lines

**Cause:** In order to improve gas marks of top surface and burr of light pipe hole, reduce the injection speed and pressure. So welding lines has not been improved.

**Action:** T2>T3>T4: Because there were other problems(gas mark/burr) at the same time, it was impossible to do much about this problem.

Now: Tooling modification to add material on the mold gate for gas marks improvement. We will add injection speed and pressure for next tooling tryout. But due to characteristic of injection mold there is always weld line around hole. We will do the best to follow the previous samples (PC).

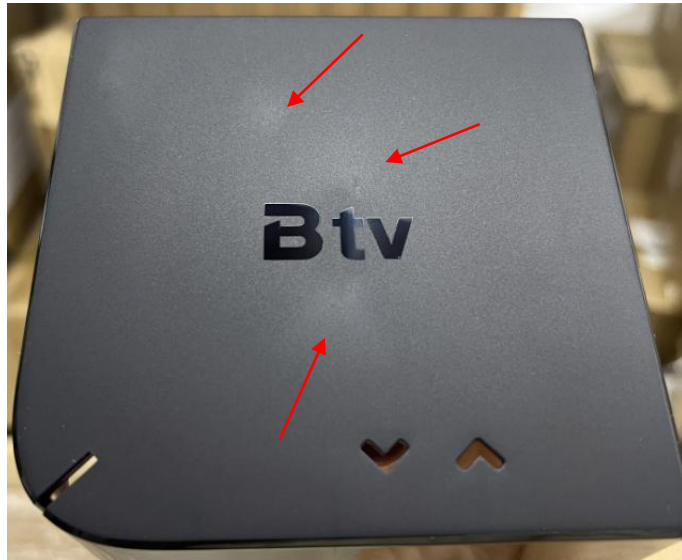
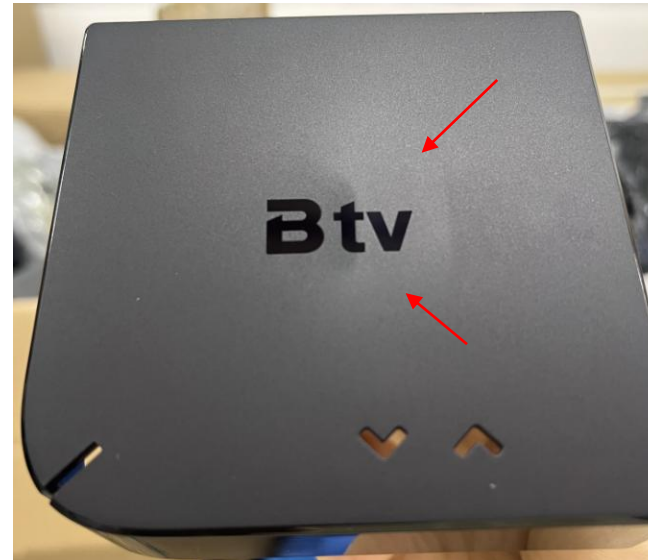
## Issue 2: Gas Marks

**Cause:** Because the texture was finer than T3, The gas marks were more obvious than T3.

**Action:** Tooling modify to add material on the mold gate for gas mark improvement. Due to characteristic of injection mold and structure of this part, there will be gas marks, stress marks on the cosmetic surfaces, But We will do the best to follow the previous samples (PC).

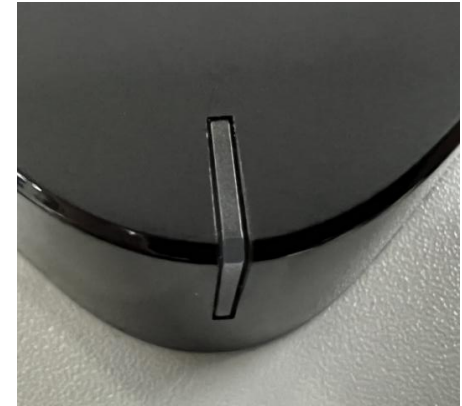
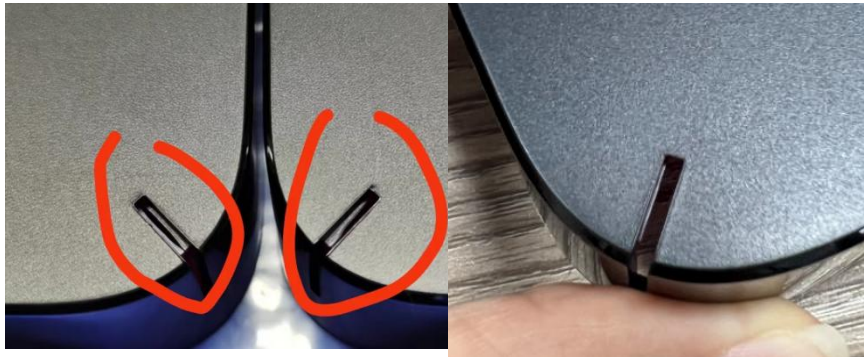
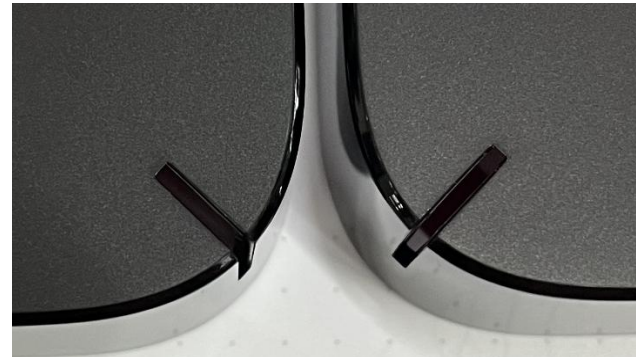
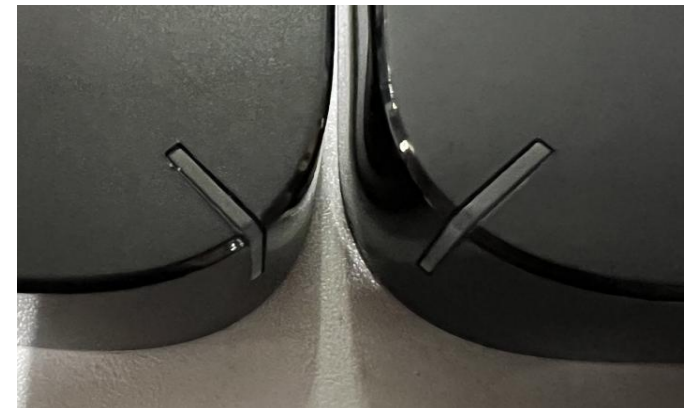
**Issue 3:** A. Burrs and drags on top cover light pipe hole. B. Large gap between top cover and light pipe.

T3>T4: Improved the core and insert fit clearance again, burrs and drags had been improved. But the size of the hole was uneven and rather large(3D spec:1.5mm(draft root), 1.55mm(draft tail)); Measured size:1.5-1.54mm(draft root), about 1.60-1.75mm(draft tail)).

**Action:** T2>T3: Burrs and drags were very serious on T2 samples, so the core and insert fit clearance were improved. Burrs had been improved on T3. But the drags issue still existed.

Now: Tooling modify to reduce material of the insert to ensure the dimension of the hole.

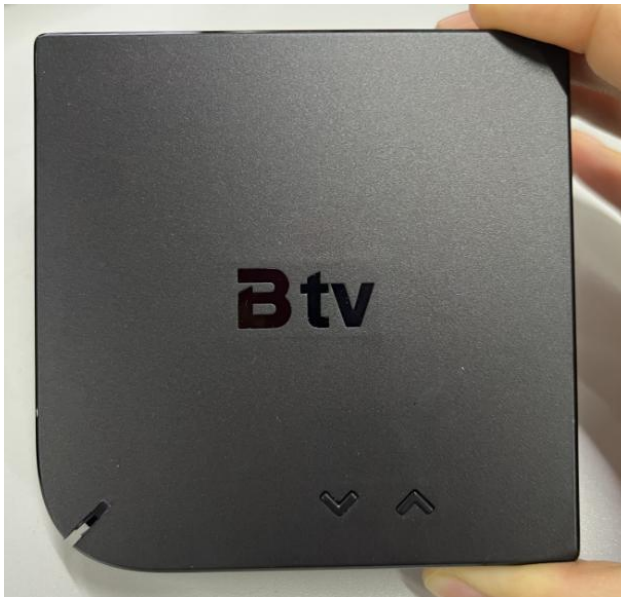
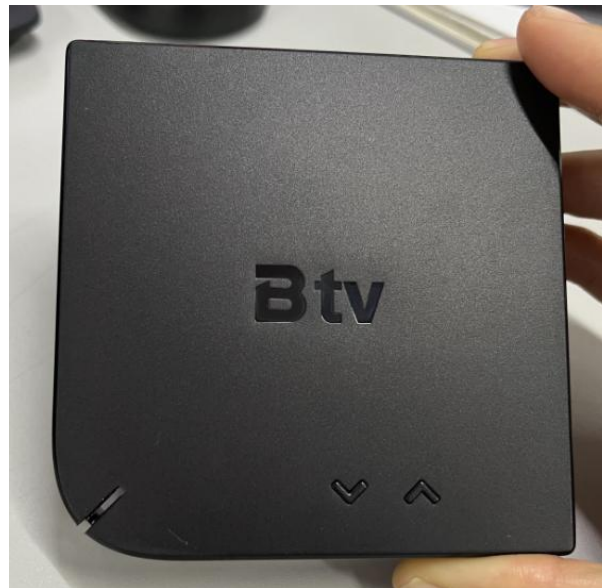
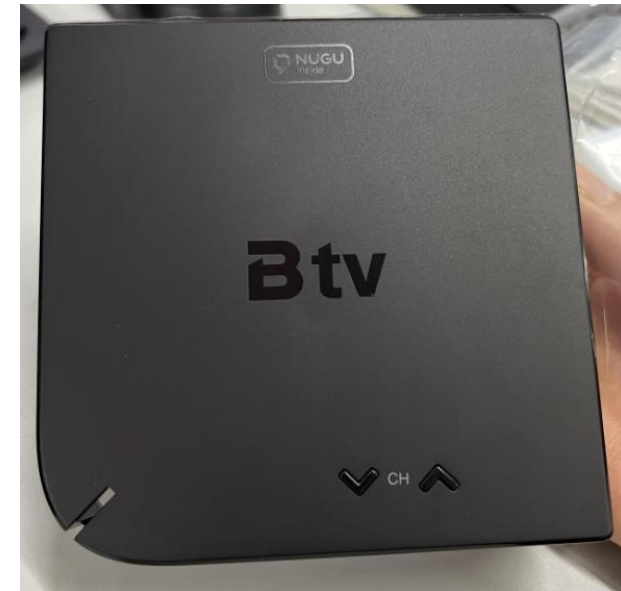
**Issue 5:** The texture of top case surface is rough.

**Action:** T2>T3: Redo the texture, the texture of T3 sample is finer than T2, but it is rougher than PC samples.

T3>T4: Follow the samples(PC material) to do texture. The texture of T4 sample is okay.

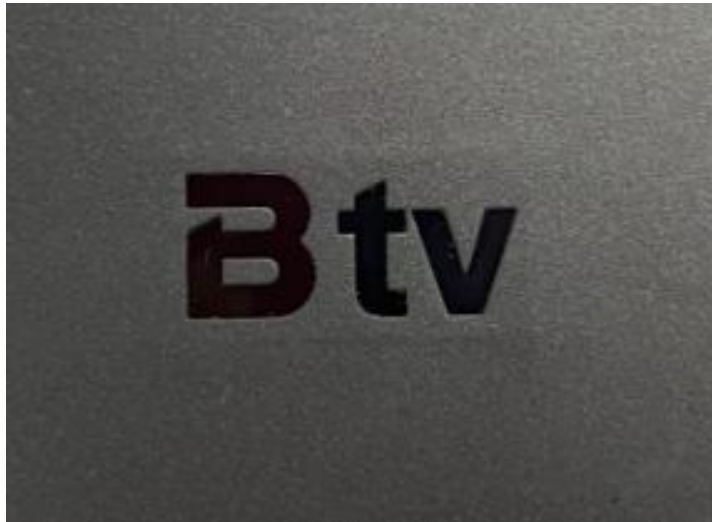
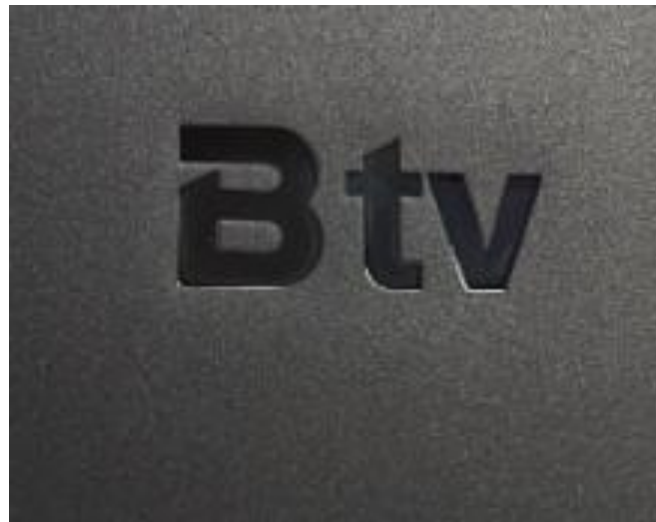
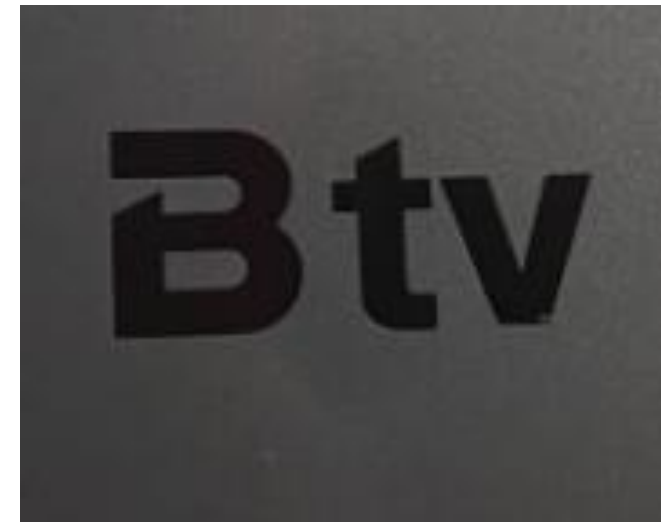
**Issue 6:** The Btv logo has to be flat with a top cover surface.

**Action:** T2>T3: Reduce the mold material, But the concavity of logo is still exist on T3 samples.

T3>T4: Modified logo technological process. The logo of T4 sample is okay.

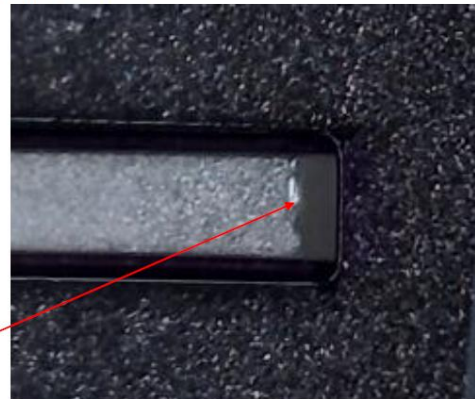
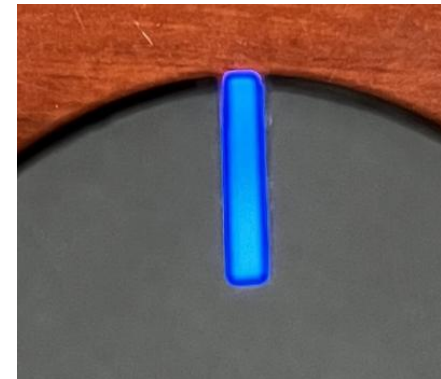
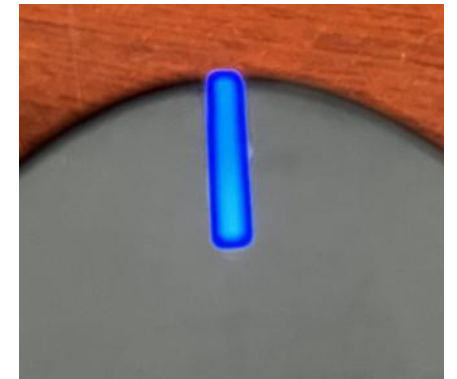
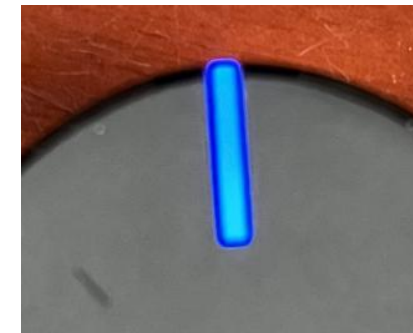
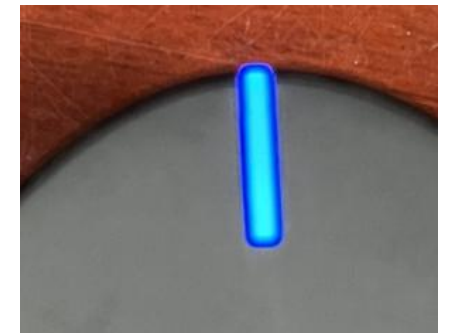
**Issue :** The chamfer of light pipe is not smooth.

**Action:** T1>T2: The chamfer is severe drag on T1. Checked and modified the corner of mold. T2 samples had much improved, but it is still exist on T2 samples.

- LED leans

- The light emitting surface is not uniform
- Make this point surface the same as the other

The light in the picture is blue instead of red because the PCBA is broken.

T2>T3: Re-checked and modified the corner of mold again and redo the texture. The chamfer of T3 sample is okay.
