# Dye & Pry Test Report

Report No: VN20220720004-1  
Sample Name: PCBA  
Applicant Department: JBD ME  
Test Item: Dye & Pry  
Test Environment: 22.0°C/51.9%RH  
Test Completion Date: Jul. 23, 2022

One samples of PCBA were received from JBD ME. In order to verify if there was crack or open in the solder joints, the dye & pry test was performed then. The specimen to be tested was specified as below.

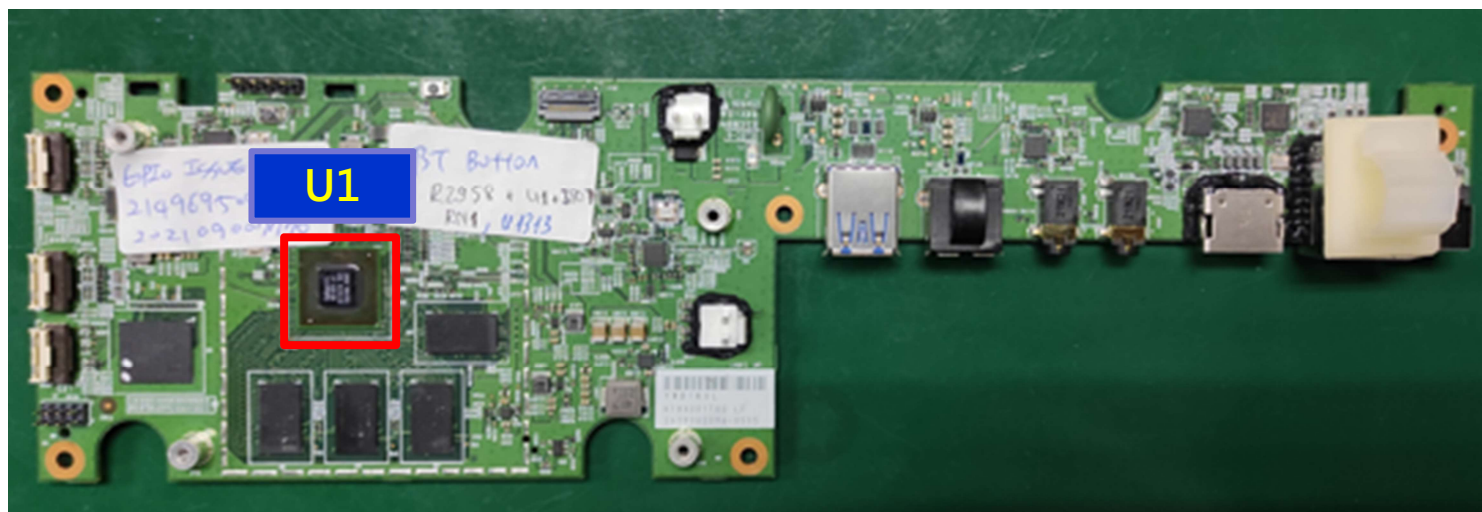
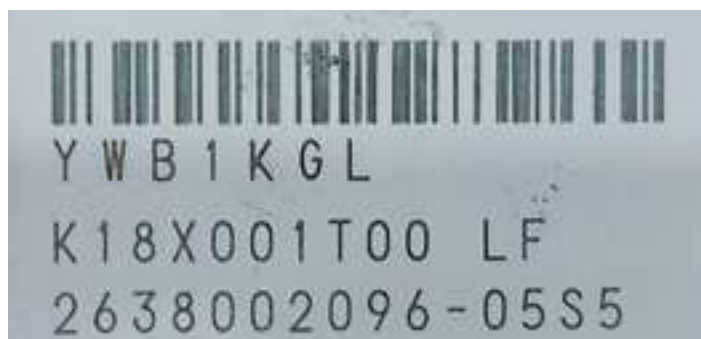
## 5. Test Location:

| Sample Name | Model | S/N | Location |
|---|---|---|---|
| PCBA | K18X001.00 | YWB1KGL | U1,U1313 |

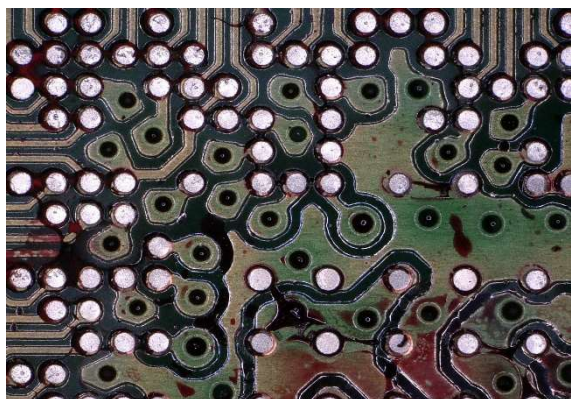
100X  
Site2

Analysis: No cracks observed . The representative photos are shown as below.

| Location | Conclusion | Remark |
|---|---|---|
| U1 | No cracks observed | Page 5~6 |
