# No booting issue\_J4 contact issue

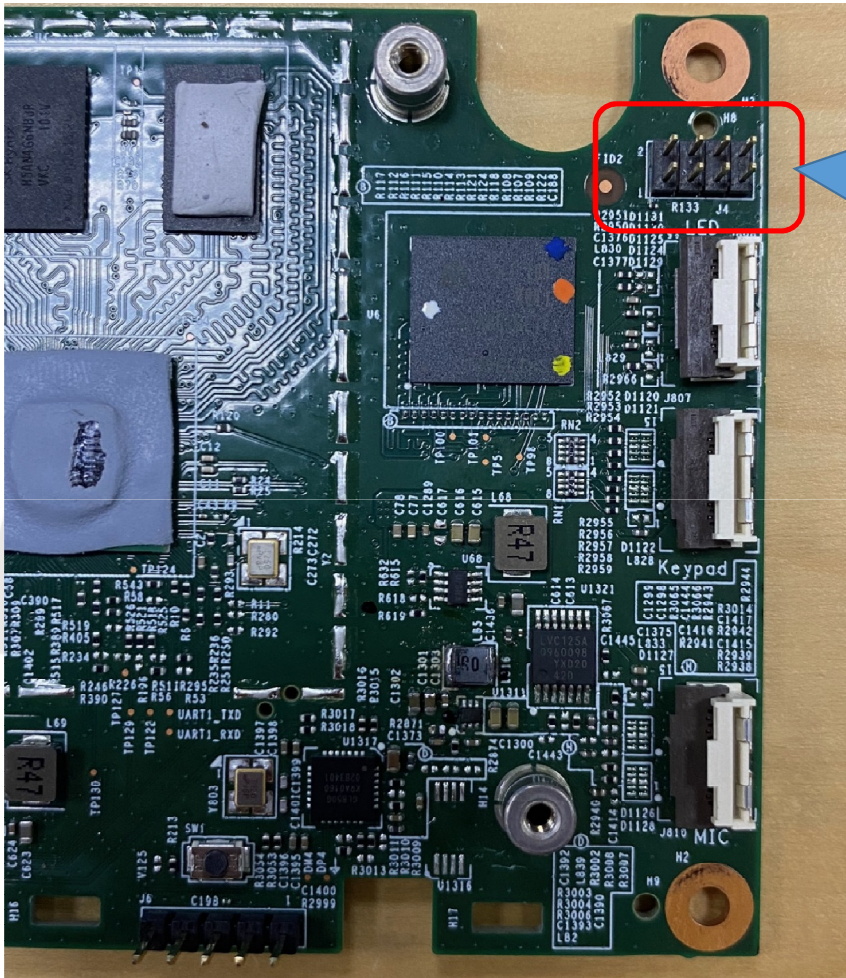
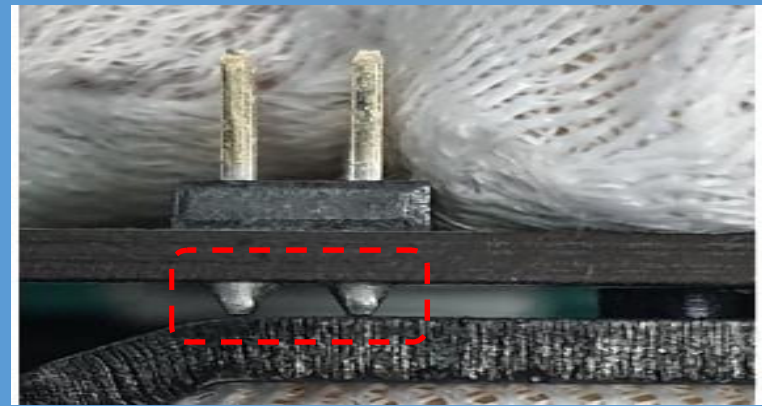
1. The J4 is used for debug port of VS550
2. The J4 pin header is very close to the bottom heat spreader of main board. If J4 is in contact with the heat spreader, the main board may not bootup properly because the 3.3V power short-circuited to ground
3. The leg of pin header changed to normal type in DVT3 build in order to solve the soldering issue on ground pin of pin header. And we will change the pin header to short leg type in MP to prevent the risk of short issue after assembly.
