# BFX-UA300

## Hardware Unit Test Report

### 4 \*MIC Test

| Hardware version | FW version | Sample No. |
|---|---|---|
| V015 | TBD | PCB S/N: YUH0FYF |

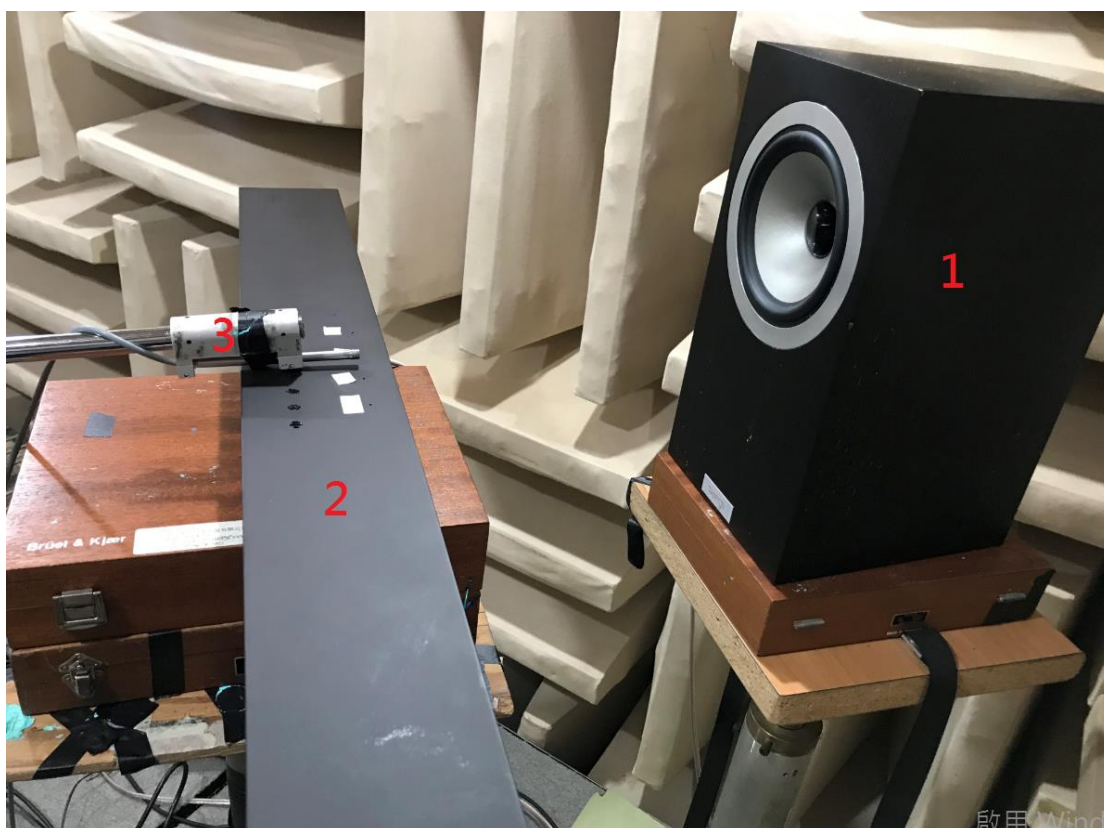
#### 1.1 Audio Test Setup & Environment

- (1) Play 1KHz Tone
- (2) DUT( 4\*Mic)
- (3) Microphone(Use for AP analysis)

Use Audio precision send 1 KHz signal and the sample rate is 48 KHz.

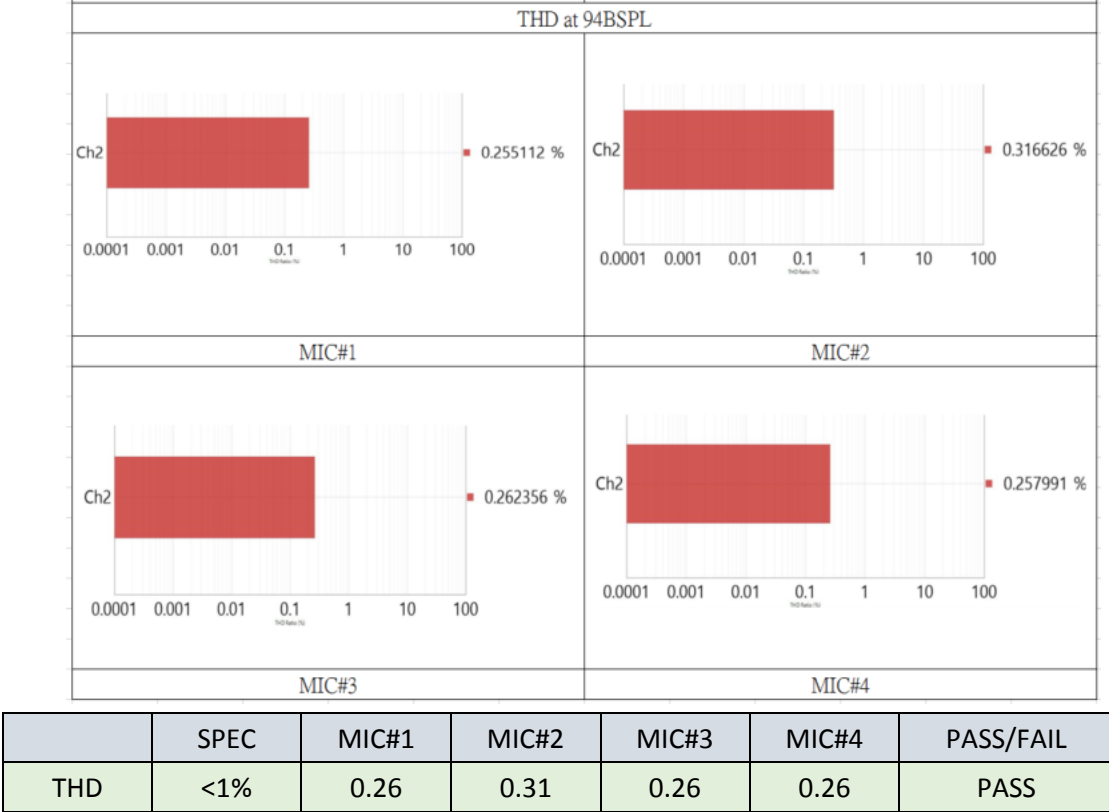
Item 3: Harmonic Distortion( Mic1~Mic4) =====> **PASS**
