# BFX-UA300

## Hardware Unit Test Report

### 4 \*MIC Test

| Hardware version | FW version | Sample No. |

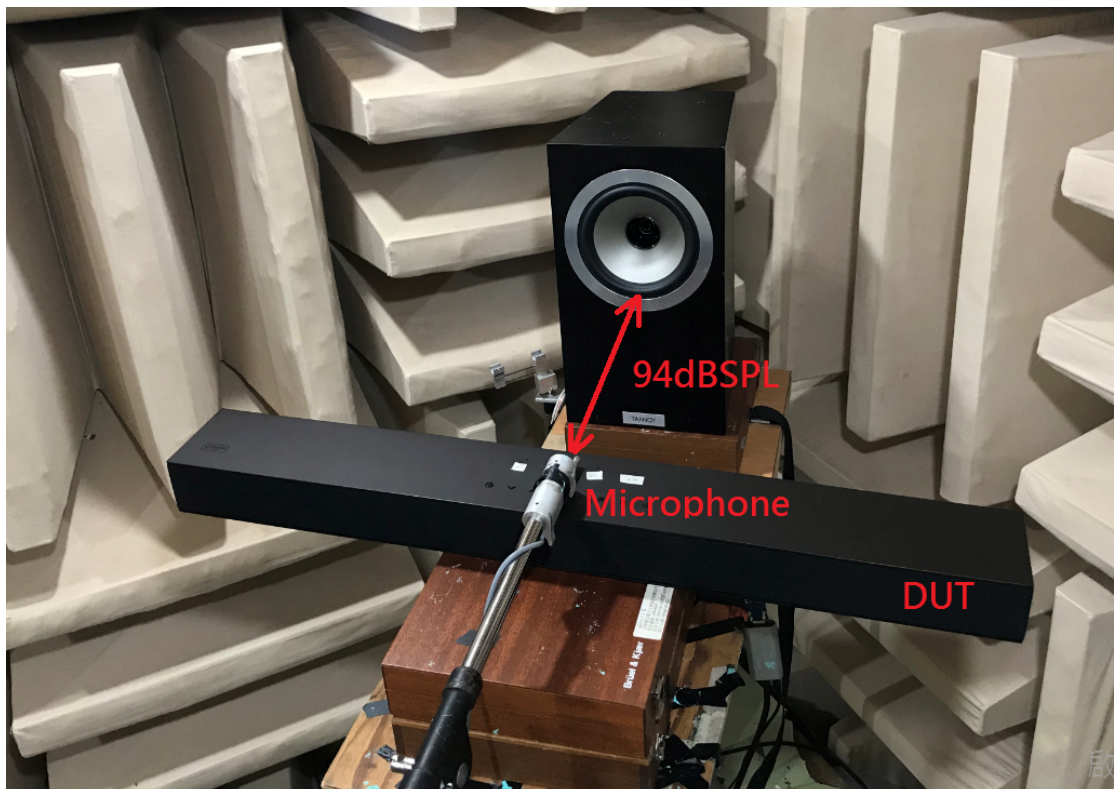
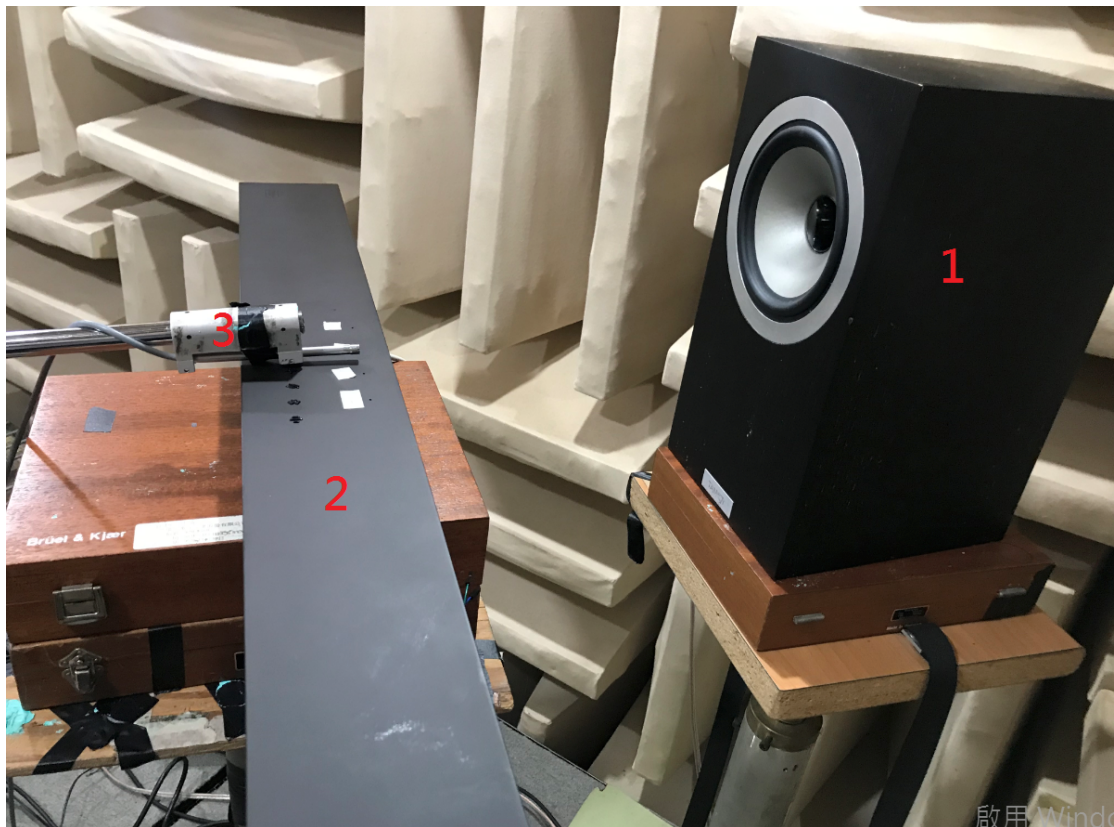
#### 1.1 Audio Test Setup & Environment

- (1) Play 1KHz Tone
- (2) DUT( 4\*Mic)
- (3) Microphone(Use for AP analysis)

Use Audio precision send 1 KHz signal and the sample rate is 48 KHz.
