# K18X001 RMA RJ45 Cable issue

**Prepared By : Mouse**  
**2022/May/07**

# I. Description Issue

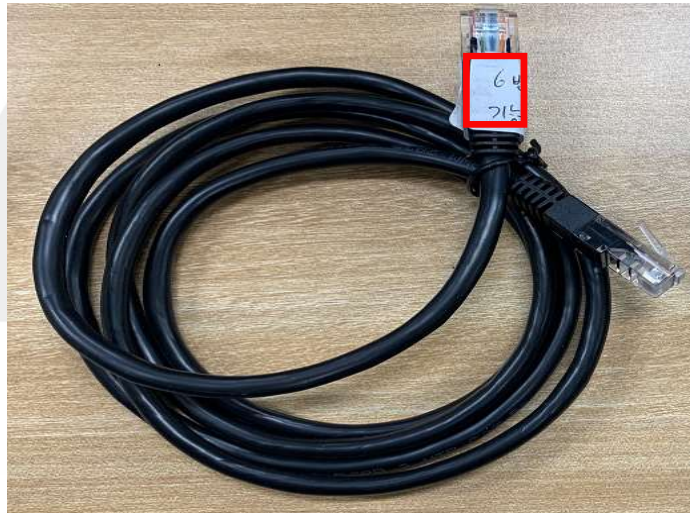
NG Sample 1

Sample 1 : 371.01056.005 Vendor : FIT  
Description : CABLE RJ45 ASSY  
Qty : 1pcs  
Issue: PIN 6 open.

**Summary:** Check visual on the surface of cable → **No abnormal found.**

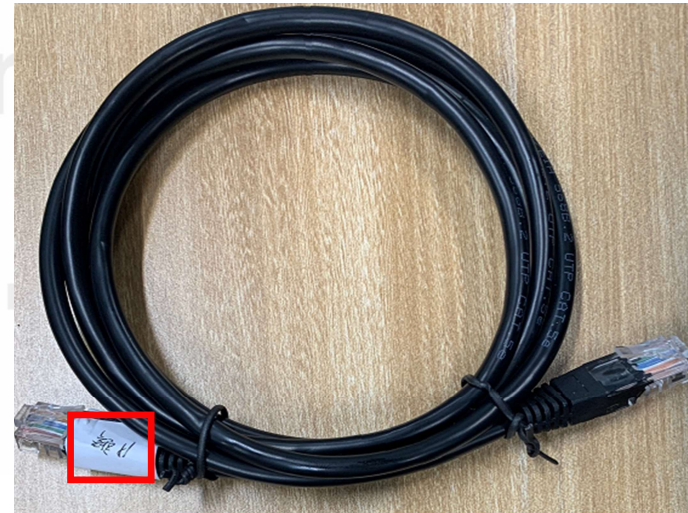
NG Sample 2

Sample 2 : 371.01056.005 Vendor : FIT  
Description : CABLE RJ45 ASSY  
Qty : 1pcs  
Issue: PIN 11 open.

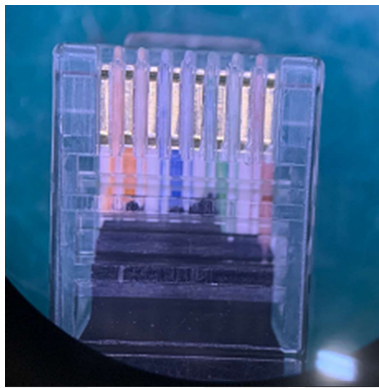
NG Sample 1

### 1. Material visual check with microscope

**Summary:** Visual check cable head by microscope no found any abnormal.

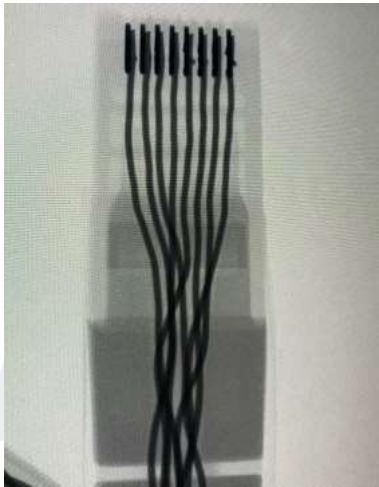
NG Sample 1

## 2. Material X-Ray check

**Summary:** X-Ray check cable head by microscope no found any abnormal.

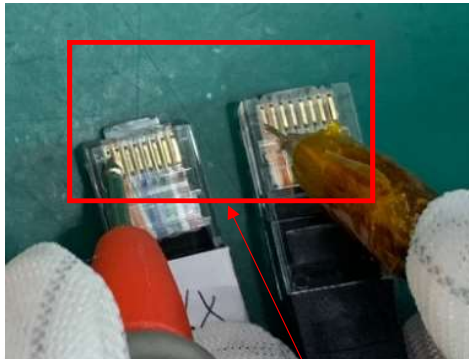
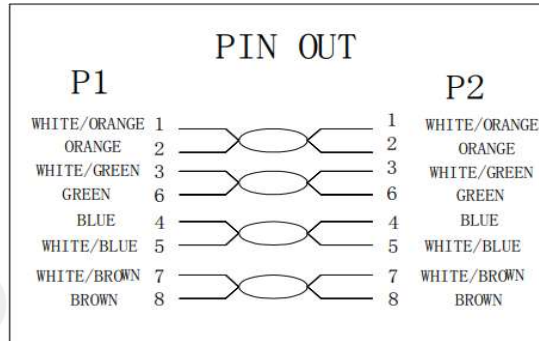
PIN OUT Diagram

## 1. Use multimeter to check RJ45 cable pin to pin connect resistance

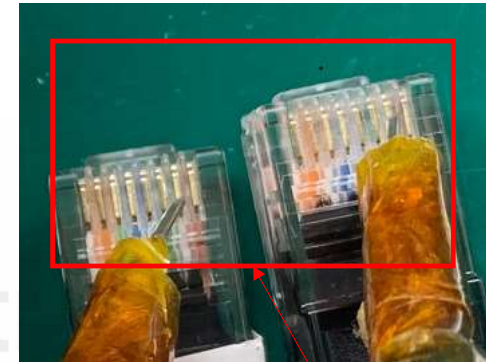
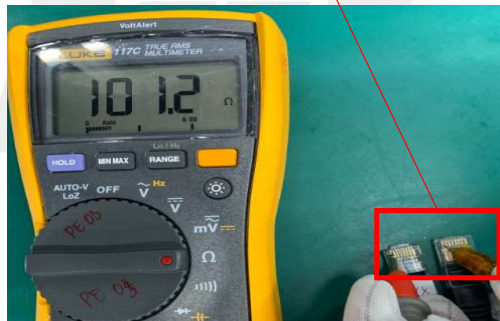
NG Sample 1  
Abnormal at PIN 1

**Summary:** PIN 1-1 (NG Sample 1) & PIN 7-7( NG Sample 2) abnormal.

1. As analysis above we realize that RJ45 have issue.
2. SQE feedback and send material issue to FIT vendor further analysis.

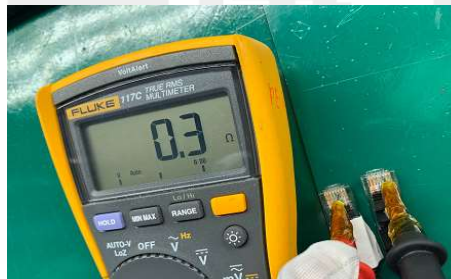
Normal value  
0.3 Ω
