# SWAN Rub and Buzz Improvement – FXN side

First Update

2020.12.14

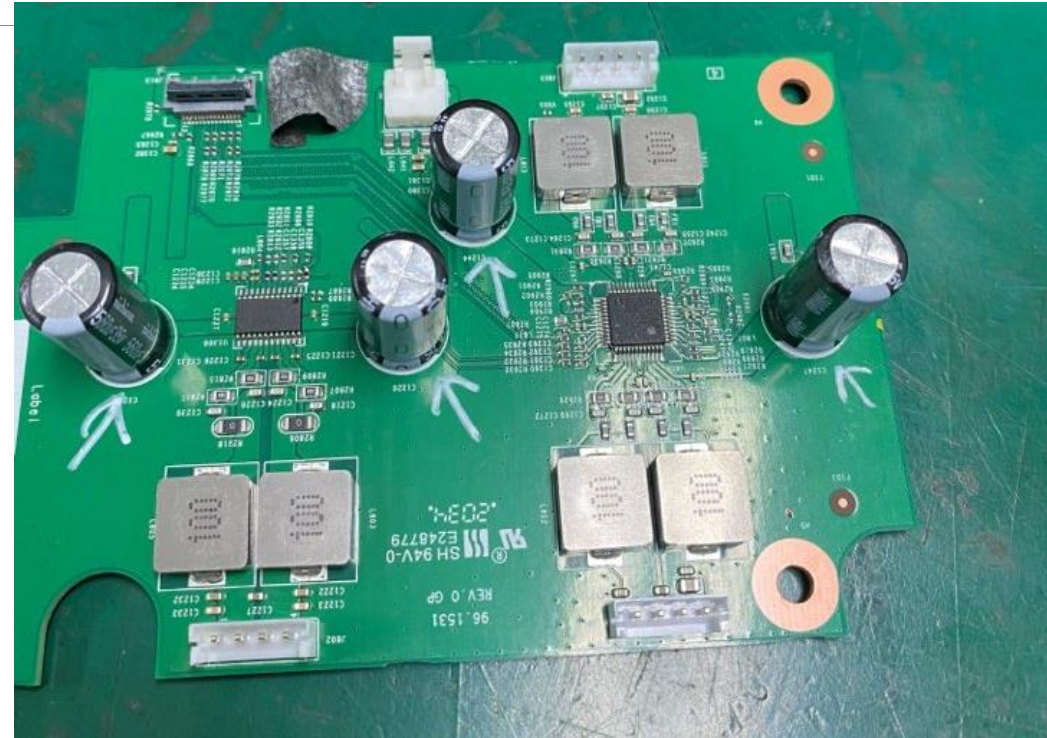
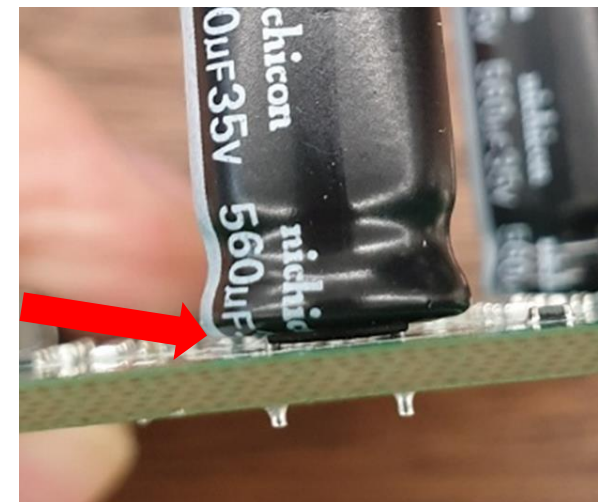
## The elec cap need to applied bonding.

: This is make 350Hz band Rub and Buzz noise.

- The elecap is not completely tight to PCB.
- due to Sound vibration is shaking the electric cap.

## Suggestion Solution

: Apply silicon between PCB and all of Elecap (4 point)

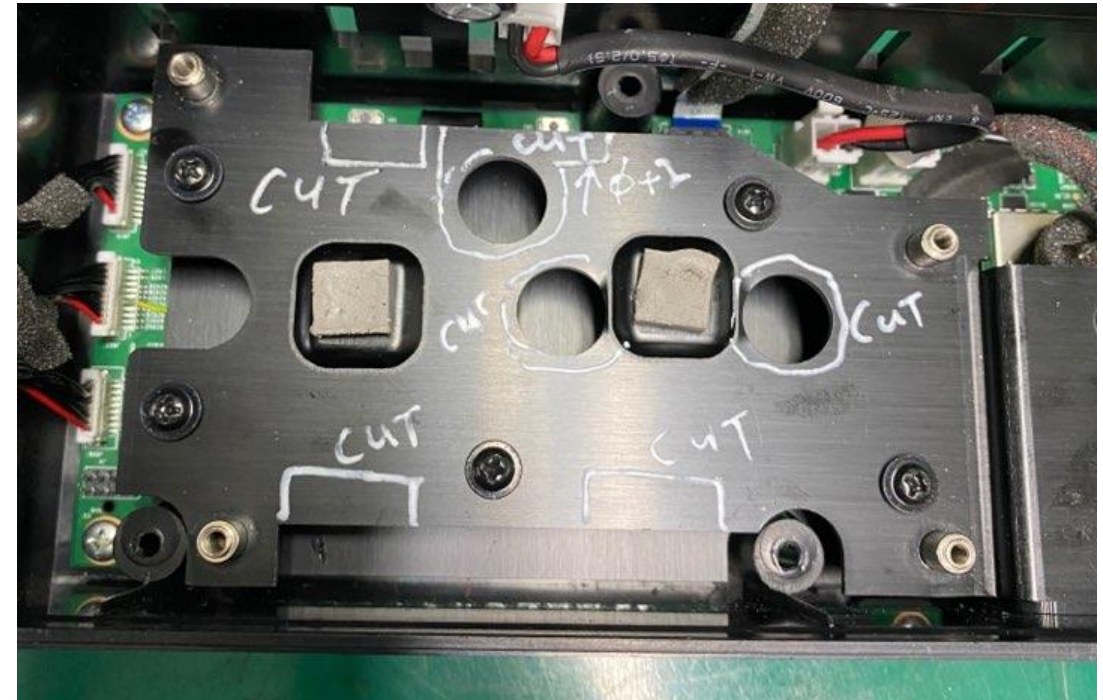
**Heat spreader is also make Rub and Buzz noise.**

: Amp PCBA and Heat spreader amp bottom is to create noise.

**Suggestion Solution**

: Cutting area adding and expanding
