# Reliability Test Report for

## BFX-AT100

### (Short term solution)

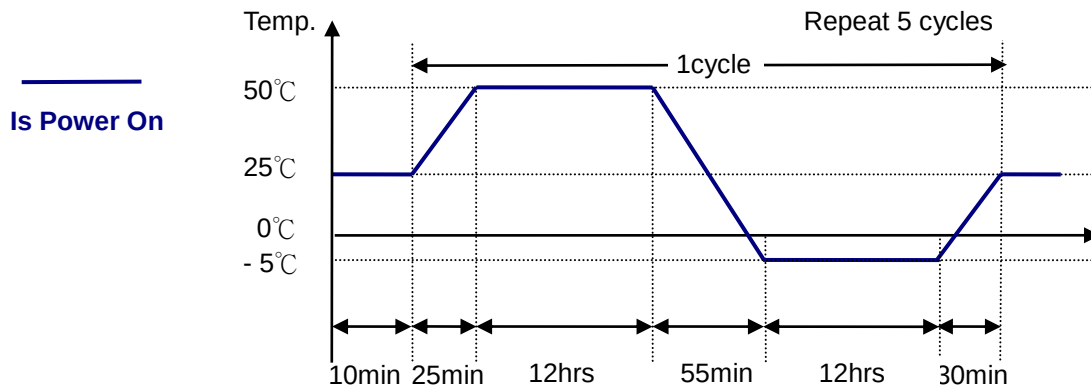
### Test Profile:

1. Power on, then activated in full function and operation.
2. Start test at 25°C for 10 min.
3. Ramp the temperature to 50°C for 12 hours.
4. Ramp the temperature to - 5°C for 12 hours.
5. Repeat item 3 ~ 4 for 5 cycles.

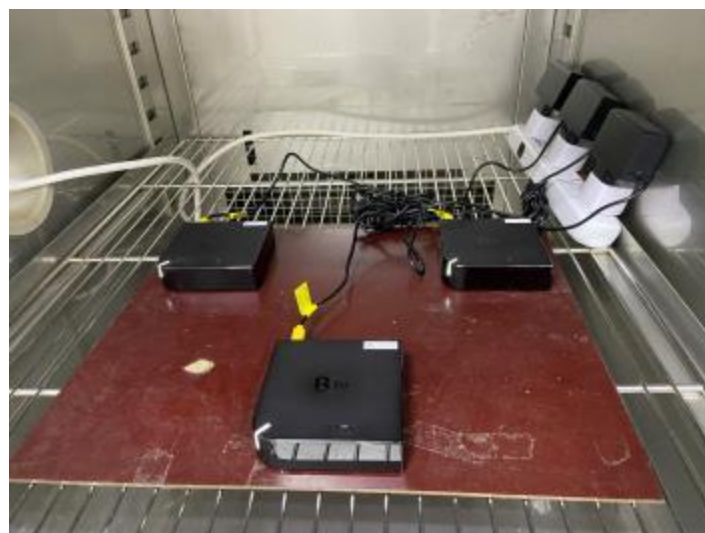
1. No functional failures both during and after the test.
2. No performance degradation during the functional test.
3. No visual damage to the products after inspection, such as peeling, discoloration, etc.

**Basis for Profile:** IEC 60068-2-30.

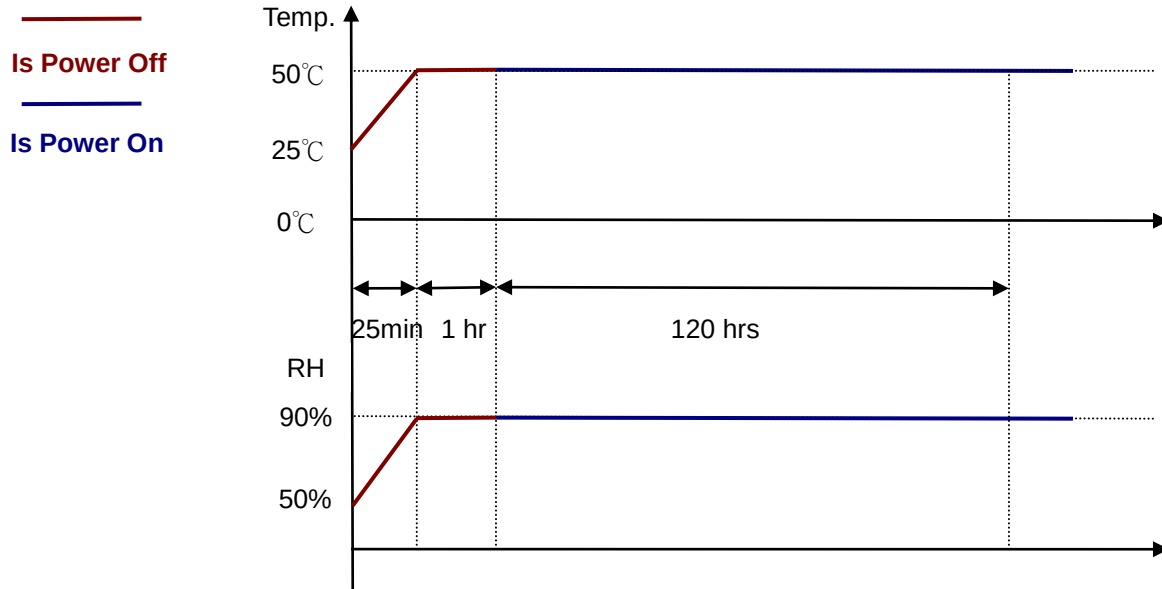
### Test Profile:

1. Power off.
2. Start test at 25°C and RH 50%.
3. Ramp the temperature to 50°C and RH 90% in 25 minutes, then hold for 1 hour.
4. Power on the test units.
5. Hold 50°C, RH 90% for 120 hours.

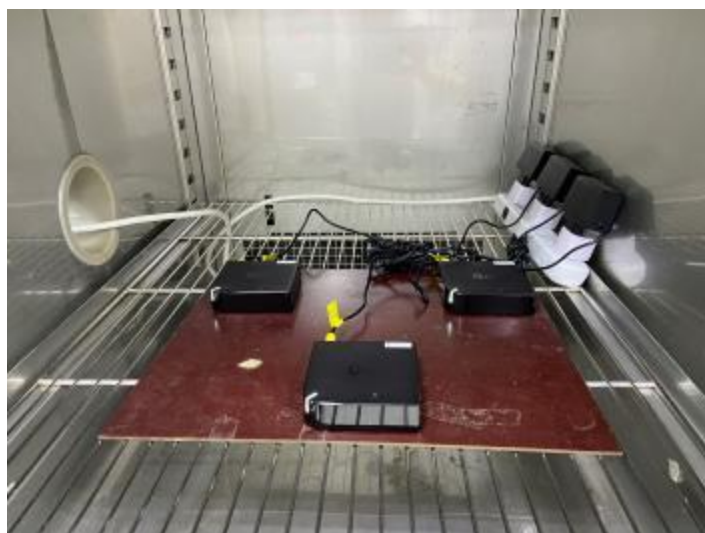
1. No functional failures both during and after the test.
2. No performance degradation during the functional test.
3. No visual damage to the products after inspection, such as peeling, discoloration, etc.

**Basis for Profile:** MIL-STD-202F Method 103B

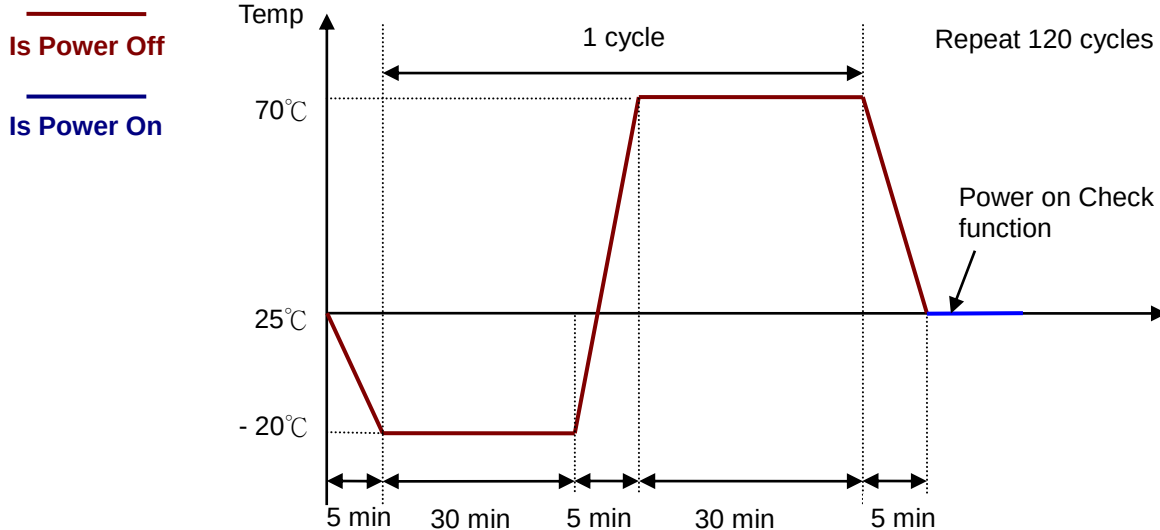
**Test Profile:**

1. Power off.
2. Start test at  $25^{\circ}\text{C}$ .
3. Ramp the temperature to  $-20^{\circ}\text{C}$  and hold for 30 minutes.
4. Ramp the temperature to  $70^{\circ}\text{C}$  and hold for 30 minutes.
5. Transfer time: 5 minutes
6. After repeat 120 cycles. Power on, then activated in full function and operation.

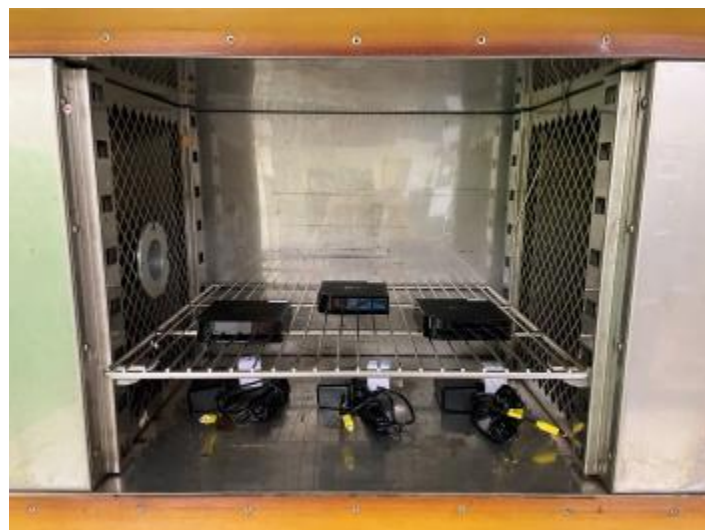
1. No functional failures both before and after the test.
2. No performance degradation after the functional test.
3. No visual damage to the products after inspection, such as peeling, discoloration, etc.

**Basis for Profile:** MIL –STD-810F Method 503.4 Procedure I.

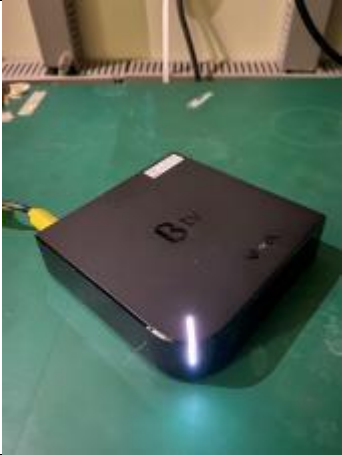
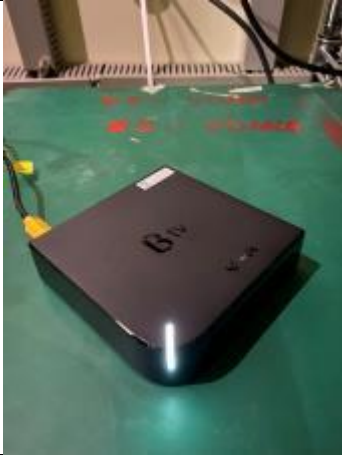
| No. | SN | Before | After | Result |
|---|---|---|---|---|
| 1 | 214968810000000000000002 | | | Visually no abnormalities |

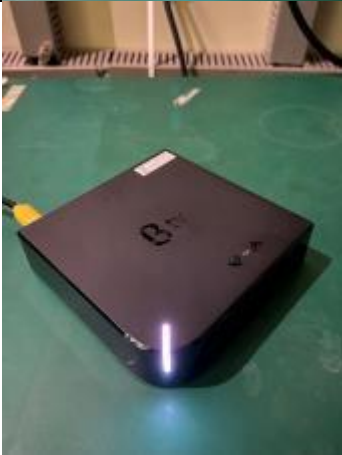
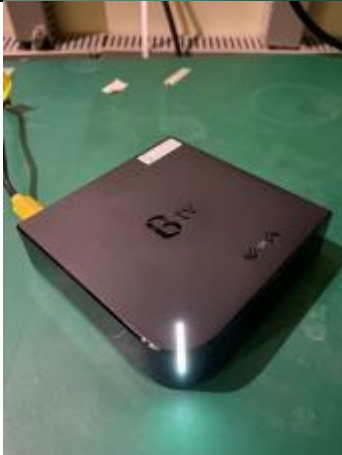
| No. | SN | Before | After | Result |
|---|---|---|---|---|
| 2 | 214968810000000000000003 | | | Visually no abnormalities |

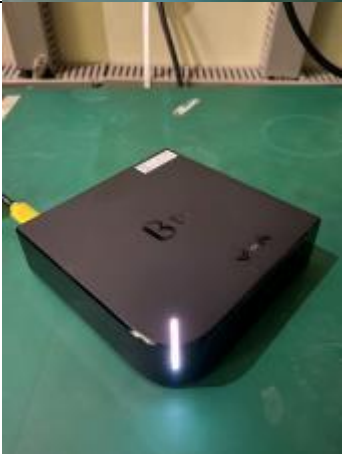
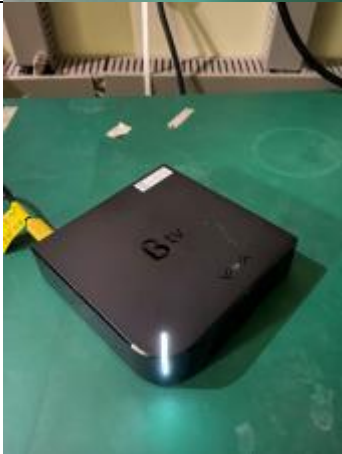
| No. | SN | Before | After | Result |
|---|---|---|---|---|
| 3 | 214968810000000000000001 | | | Visually no abnormalities |

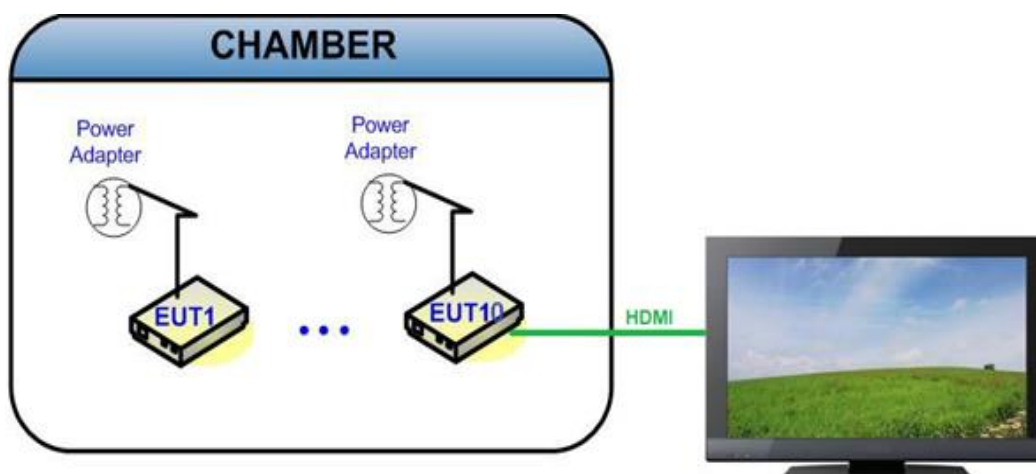
**Test Block Diagram:**

The RDT (Reliability Demonstration Test) test is necessary to quantify the expected service life of a product. It specifies how the test is to be performed. Demonstrated MTBF (Mean Time Between Failure), the MTBF target is 17,520 hours.

If it based on the Foxconn standard MTBF calculation formula. Demonstrated MTBF (Mean Time Between Failure) will be based on the methods defined in MIL-STD-781D. The MTBF target is 17,520 hours. Based on 90 % confidence level, it will take **21 days with 10 pieces** of samples under 50 deg C. The formula below shows how the MTBF is defined.

It needs **21 days** to test with 0 defects to achieve the goal of **18,050.95429 hours** MTBF.

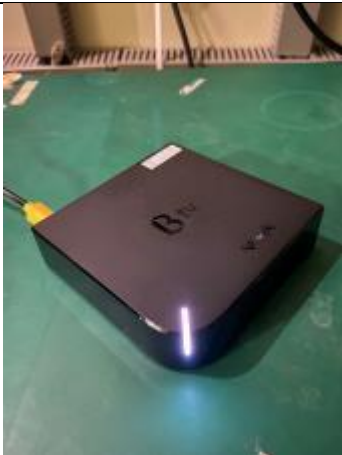
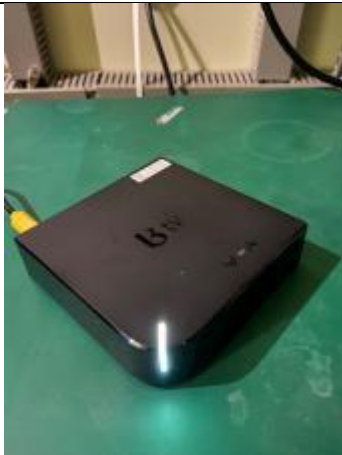
| No. | SN | Before | After | Result |
|---|---|---|---|---|
| 1 | 2149688100000000000014 | | | Visually no abnormalities |

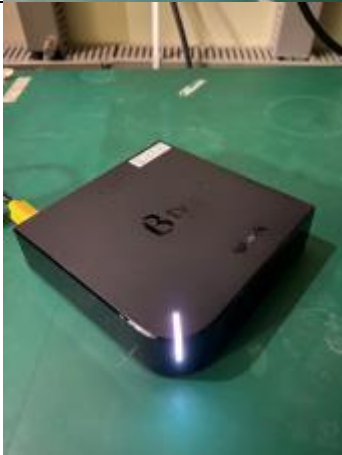
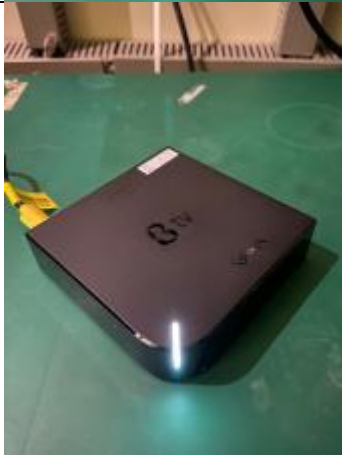
| No. | SN | Before | After | Result |
|---|---|---|---|---|
| 2 | 2149688100000000000016 | | | Visually no abnormalities |

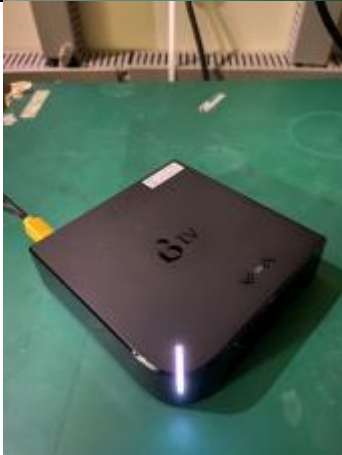
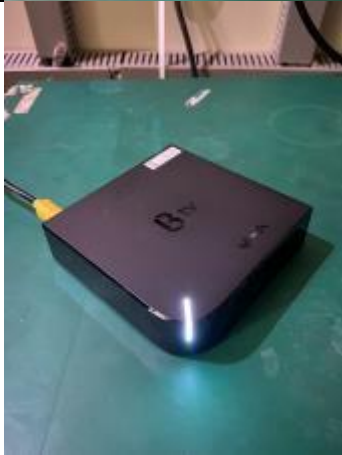
| No. | SN | Before | After | Result |
|---|---|---|---|---|
| 3 | 2149688100000000000019 | | | Visually no abnormalities |

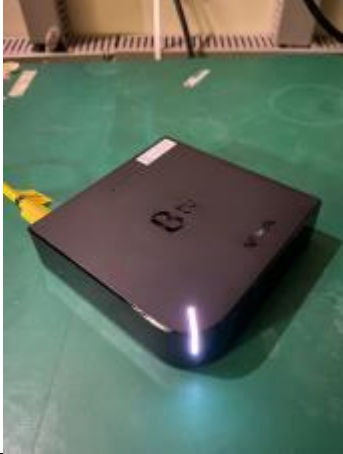
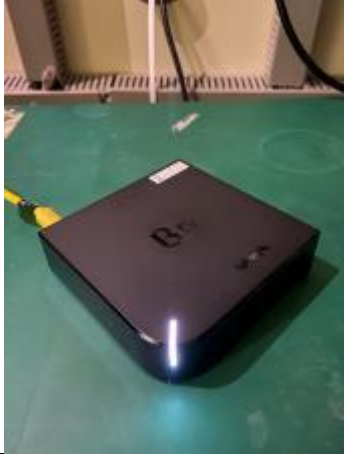
| 4 | 21496881000000000000013 | | | Visually no abnormalities |

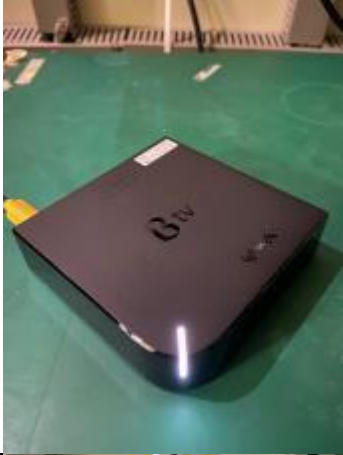
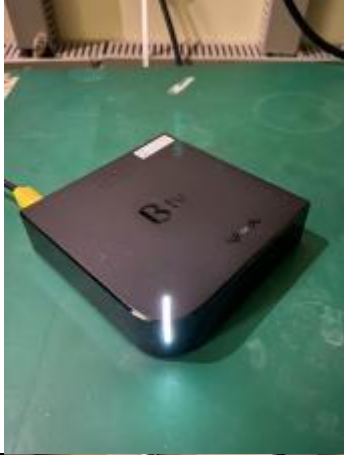
| 5 | 21496881000000000000012 | | | Visually no abnormalities |

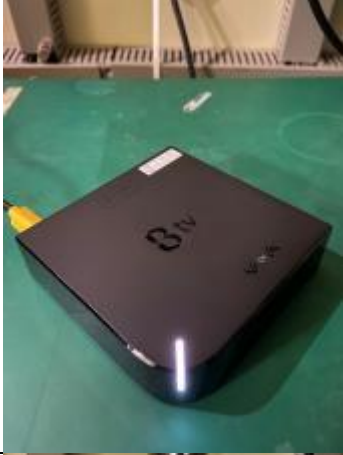
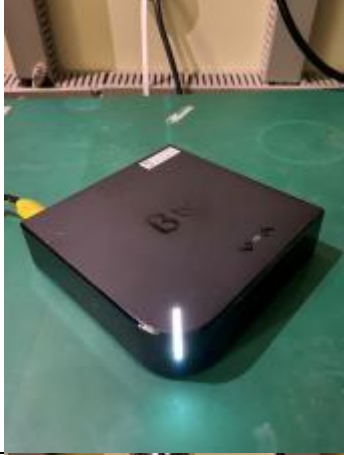
| 6 | 21496881000000000000017 | | | Visually no abnormalities |

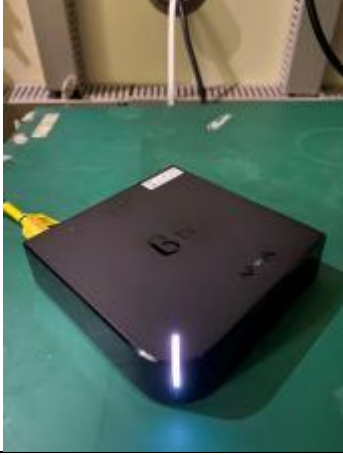
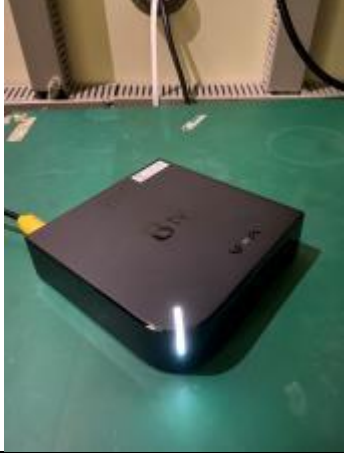
| 7 | 21496881000000000000018 | | | Visually no abnormalities |

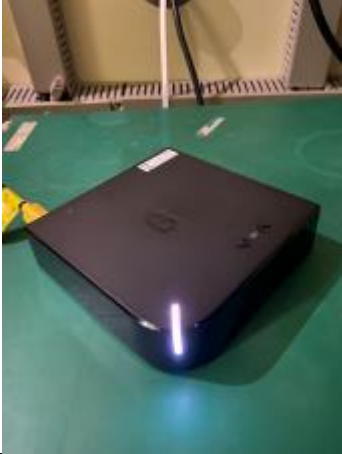
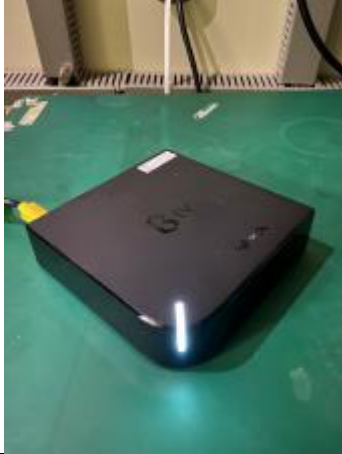
| 8 | 214968810000000000000011 | | | Visually no abnormalities |

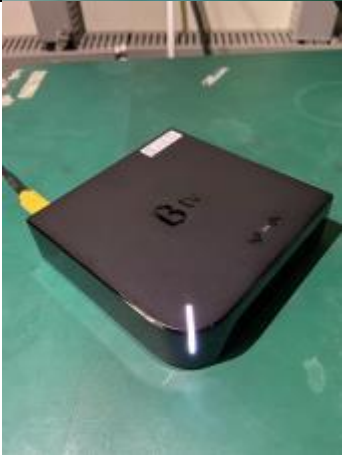
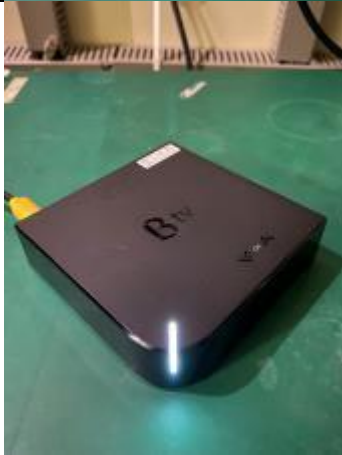
| 9 | 214968810000000000000015 | | | Visually no abnormalities |

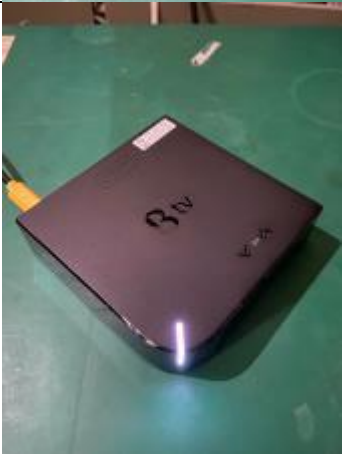
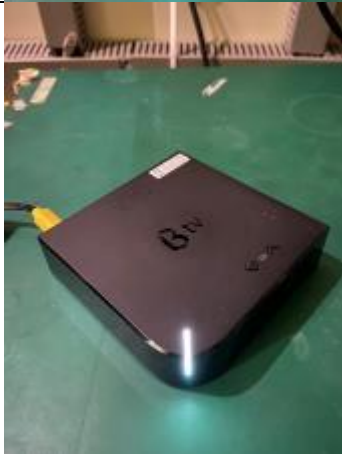
| 10 | 214968810000000000000020 | | | Visually no abnormalities |
