# Comparison of Main source and 2<sup>nd</sup> source

## Test Report

T99X171T00 2nd source introduce ETA5056VXXS2F

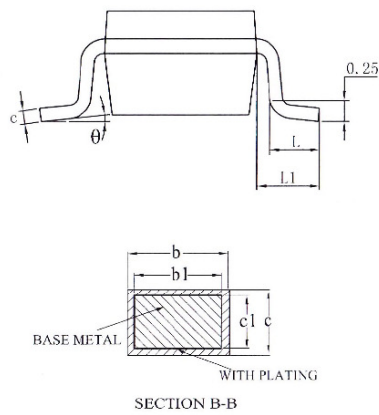
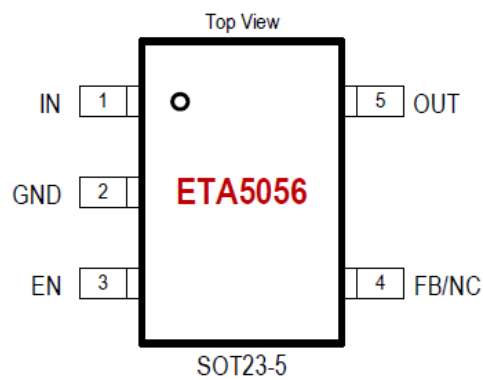
Package: SOT23-5

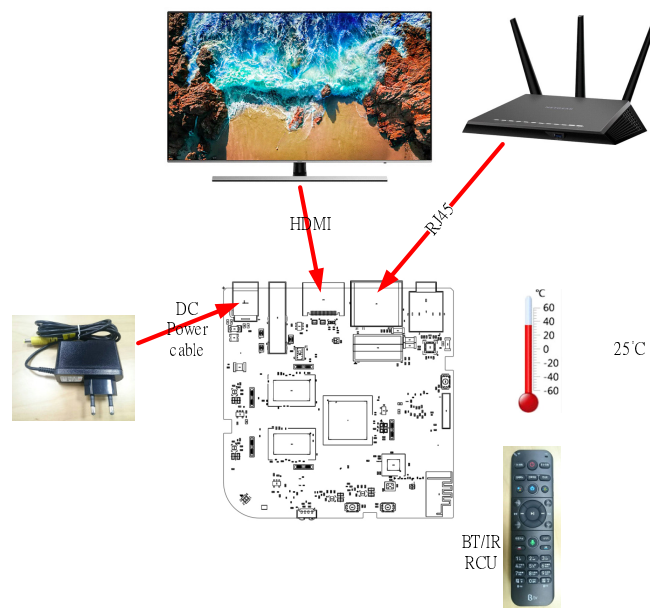
The measure test point is LDO\_P2V5 and the capacitor C334

Emmc\_VDDQ and the capacitor C322

P1V8 and the capacitor C337

all items can be measured by Oscilloscope.

Oscilloscope: TDS5054B

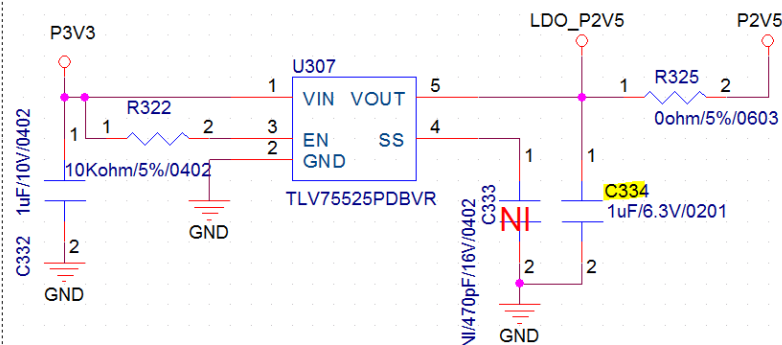
### P3V3 to P2V5

Design Max: 500mA

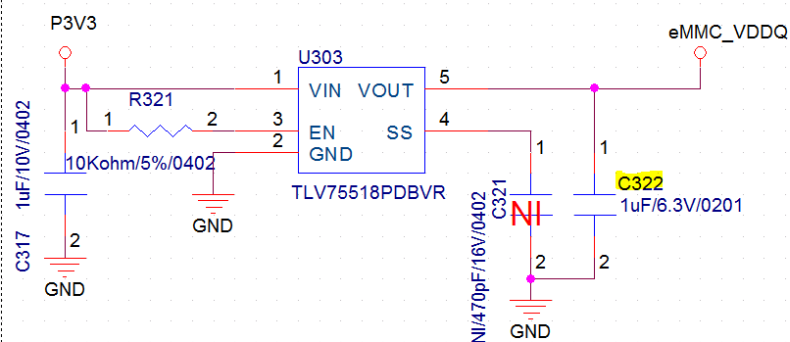
### P3V3 to eMMC\_VDDQ

Design Max: 500mA

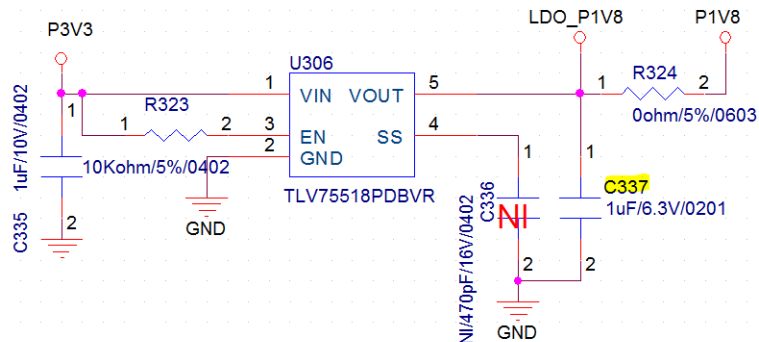
### P3V3 to P1V8

Design Max: 500mA

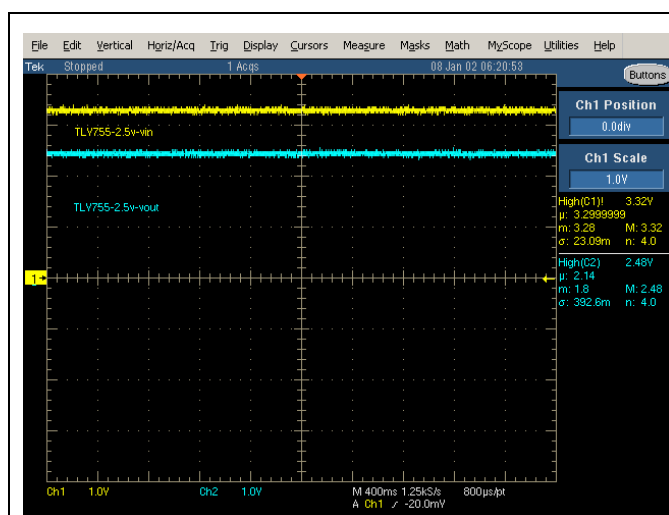
Fig. 1: Main\_LDO\_P2V5\_Vin Vout

| Power Rail | Power IC / MOSFET P/N | Spec | Measurement point | Result | Picture | Result Pass/Fail |
|---|---|---|---|---|---|---|
| Main_LDO_P2V5_Vin Vout | TLV75525PDBVR | 3.14V-3.46V<br>2.38V-2.62V | U307 pin1<br>U307 pin5 | 3.32V<br>2.48V | Fig. 1 | Pass |

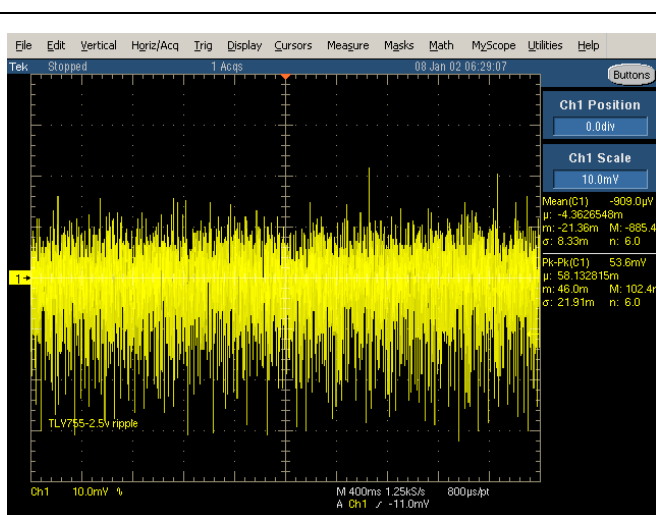
Fig. 2: Main\_LDO\_P2V5\_ripple

| Power Rail | Power IC / MOSFET P/N | Spec | Measurement point | Result | Picture | Result Pass/Fail |
|---|---|---|---|---|---|---|
| Main_LDO_P2V5_ripple | TLV75525PDBVR | <125mV | C334 | 53.6mV | Fig. 2 | Pass |

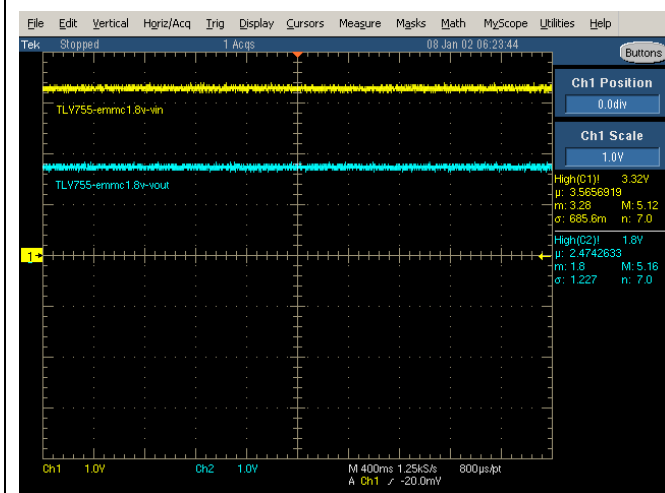
Fig. 3: Main\_eMMC\_VDDQ\_Vin Vout

| Power Rail | Power IC / MOSFET P/N | Spec | Measurement point | Result | Picture | Result Pass/Fail |
|---|---|---|---|---|---|---|
| Main_eMMC_VDDQ_Vin Vout | TLV75518PDBVR | 3.14V-3.46V<br>1.71V-1.89V | C303 pin1<br>C303 pin5 | 3.32V<br>1.8V | Fig. 3 | Pass |

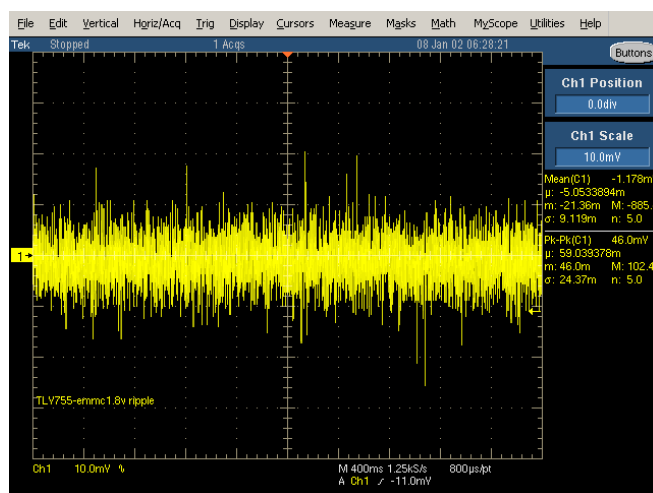
Fig. 4: Main\_eMMC\_VDDQ\_ripple

| Power Rail | Power IC / MOSFET P/N | Spec | Measurement point | Result | Picture | Result Pass/Fail |
|---|---|---|---|---|---|---|
| Main_eMMC_VDDQ_ripple | TLV75518PDBVR | <90mV | C322 | 46mV | Fig. 4 | Pass |

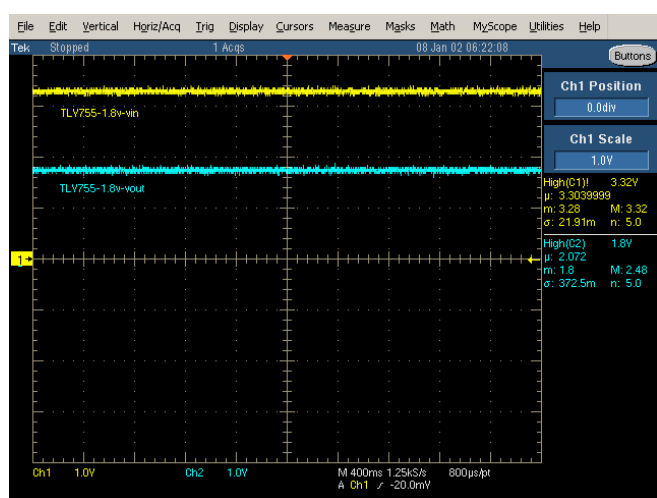
Fig. 5: Main\_LDO\_P1V8\_Vin Vout

| Power Rail | Power IC / MOSFET P/N | Spec | Measurement point | Result | Picture | Result Pass/Fail |
|---|---|---|---|---|---|---|
| Main_LDO_P1V8_Vin Vout | TLV75518PDBVR | 3.14V-3.46V<br>1.71V-1.89V | U306 pin1<br>U306 pin5 | 3.32V<br>1.8V | Fig. 5 | Pass |

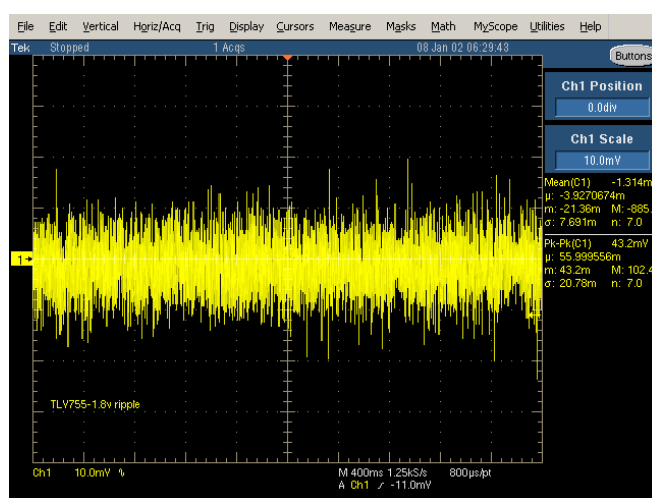
Fig. 6: Main\_LDO\_P1V8\_ripple

| Power Rail | Power IC / MOSFET P/N | Spec | Measurement point | Result | Picture | Result Pass/Fail |
|---|---|---|---|---|---|---|
| Main_LDO_P1V8_ripple | TLV75518PDBVR | <90mV | C337 | 43.2mV | Fig. 6 | Pass |

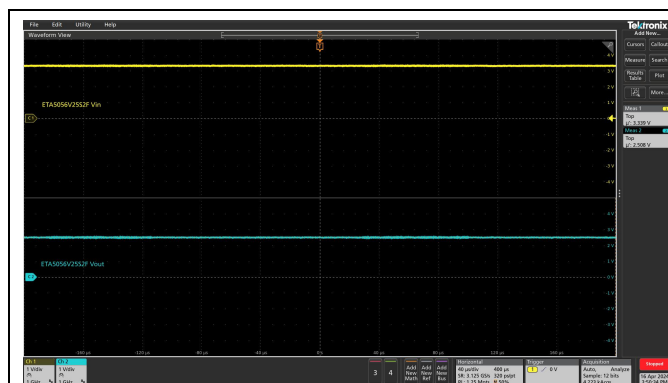
Fig. 7: 2nd\_LDO\_P2V5\_Vin Vout

| Power Rail | Power IC / MOSFET P/N | Spec | Measurement point | Result | Picture | Result Pass/Fail |
|---|---|---|---|---|---|---|
| 2 <sup>nd</sup> _LDO_P2V5_Vin Vout | ETA5056V25S2F | 3.14V-3.46V<br>2.38V-2.62V | U307 pin1<br>U307 pin5 | 3.339V<br>2.508V | Fig. 7 | Pass |

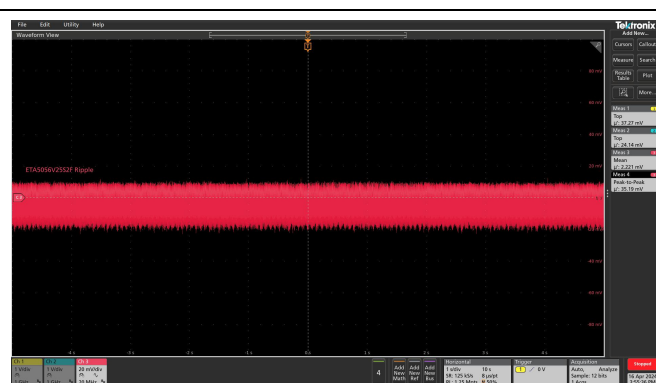
Fig. 8: 2nd\_LDO\_P2V5\_ripple

| Power Rail | Power IC / MOSFET P/N | Spec | Measurement point | Result | Picture | Result Pass/Fail |
|---|---|---|---|---|---|---|
| 2 <sup>nd</sup> _LDO_P2V5_ripple | ETA5056V25S2F | <125mV | C334 | 35.19mV | Fig. 8 | Pass |

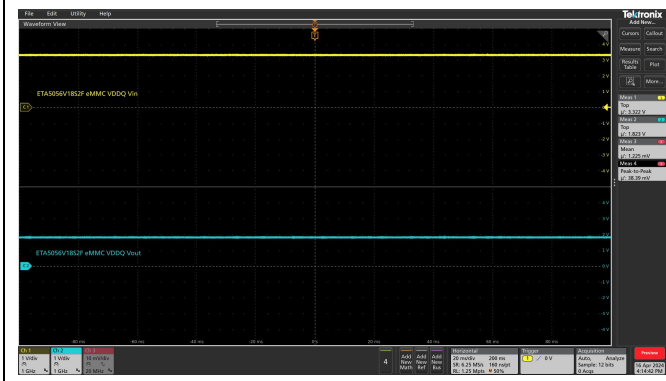
Fig. 9: 2nd\_eMMC\_VDDQ\_Vin Vout

| Power Rail | Power IC / MOSFET P/N | Spec | Measurement point | Result | Picture | Result Pass/Fail |
|---|---|---|---|---|---|---|
| 2 <sup>nd</sup> _eMMC_VDDQ_Vin Vout | ETA5056V18S2F | 3.14V-3.46V<br>1.71V-1.89V | C303 pin1<br>C303 pin5 | 3.322V<br>1.823V | Fig. 9 | Pass |

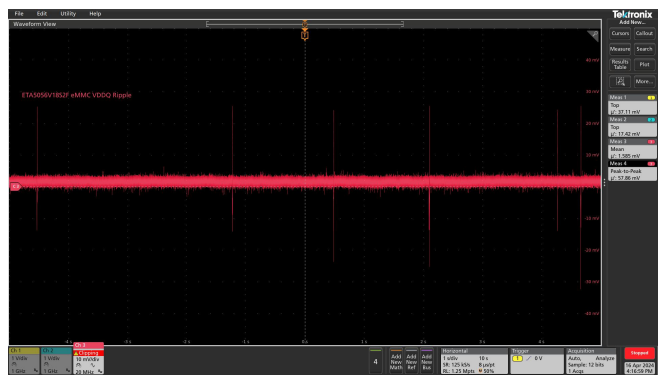
Fig. 10: 2nd\_eMMC\_VDDQ\_ripple

| Power Rail | Power IC / MOSFET P/N | Spec | Measurement point | Result | Picture | Result Pass/Fail |
|---|---|---|---|---|---|---|
| 2 <sup>nd</sup> _eMMC_VDDQ_ripple | ETA5056V18S2F | <90mV | C322 | 57.86mV | Fig. 10 | Pass |

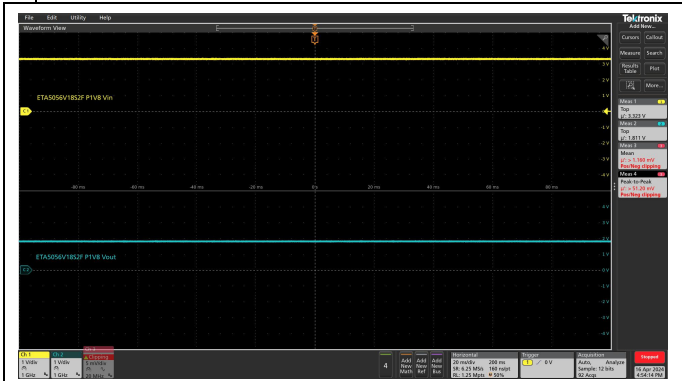
Fig. 11: 2nd\_LDO\_P1V8\_Vin Vout

| Power Rail | Power IC / MOSFET P/N | Spec | Measurement point | Result | Picture | Result Pass/Fail |
|---|---|---|---|---|---|---|
| 2 <sup>nd</sup> _LDO_P1V8_Vin Vout | ETA5056V18S2F | 3.14V-3.46V<br>1.71V-1.89V | U306 pin1<br>U306 pin5 | 3.323V<br>1.811V | Fig. 11 | Pass |

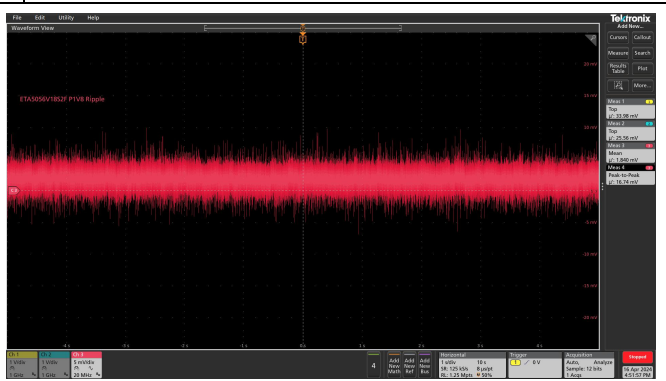
Fig. 12: 2nd\_LDO\_P1V8\_ripple

| Power Rail | Power IC / MOSFET P/N | Spec | Measurement point | Result | Picture | Result Pass/Fail |
|---|---|---|---|---|---|---|
| 2 <sup>nd</sup> _LDO_P1V8_ripple | ETA5056V18S2F | <90mV | C337 | 16.74mV | Fig. 12 | Pass |
