## Component Failure Analysis Request Form

| Description: | IC PER 1.8/3.3V SMD FCBGA393 GP ARM |
| Model Name: | T99X171T00/T99X171.00 |

## Failure Analysis: ( Board Level)

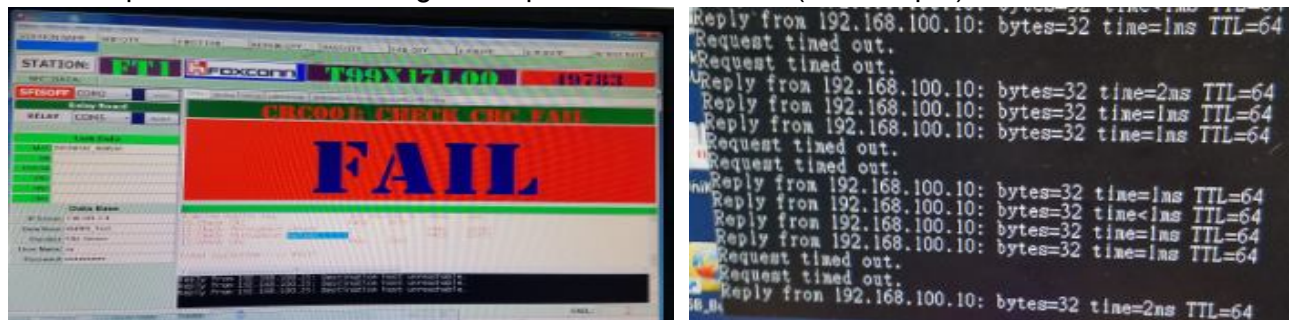
ATE picture1: Ethernet Ping interrupt and CRC test fail (NG sample)

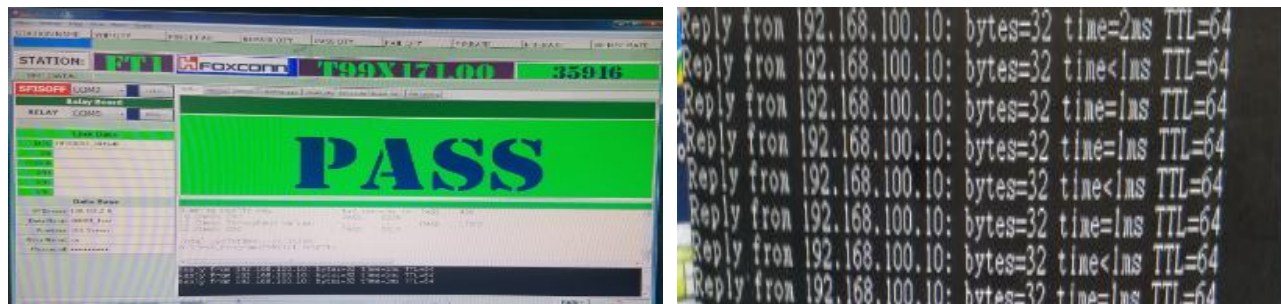
ATE picture2: Ethernet Ping stable and CRC test PASS (OK sample)

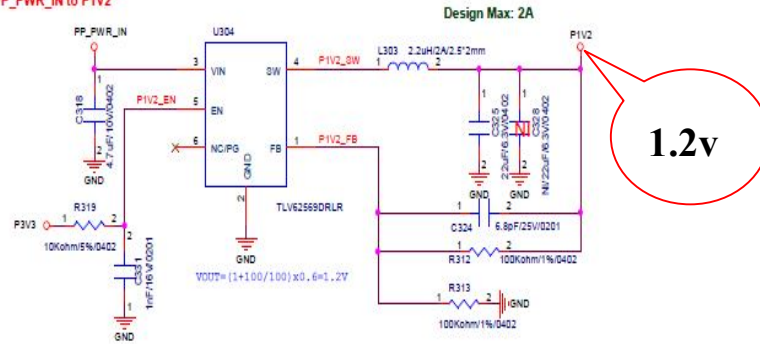
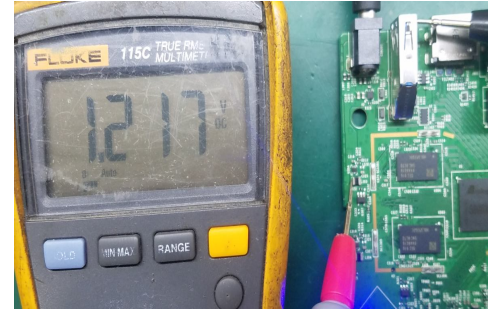
#### PP\_PWR\_IN to P1V2

1. No issue was found with power rail:

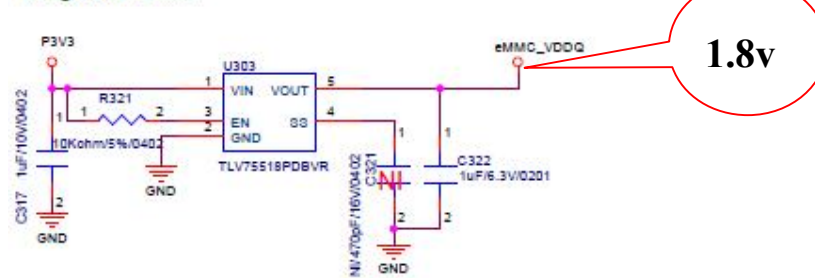
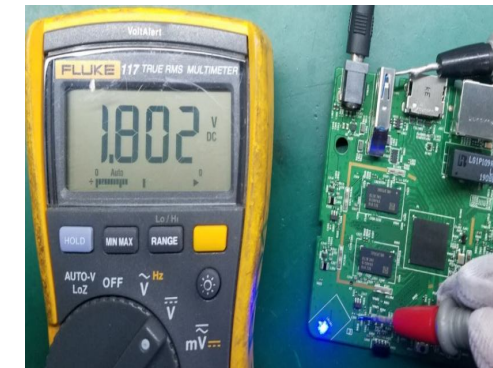
#### P3V3 to eMMC\_VDDQ

Design Max: 500mA

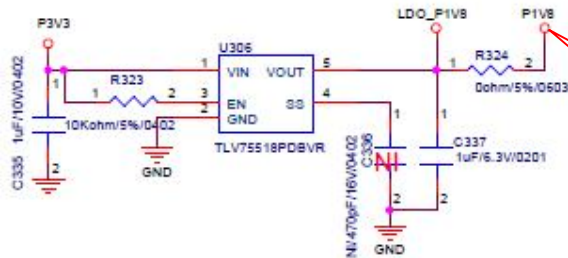
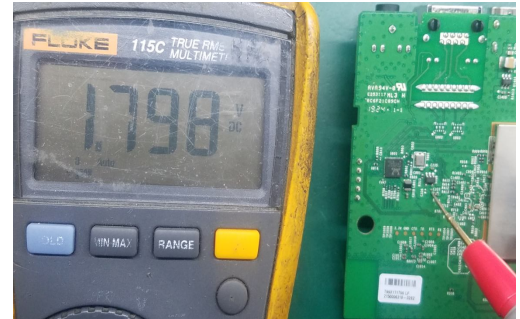
### P3V3 to P1V8

Design Max: 500mA

1.8v

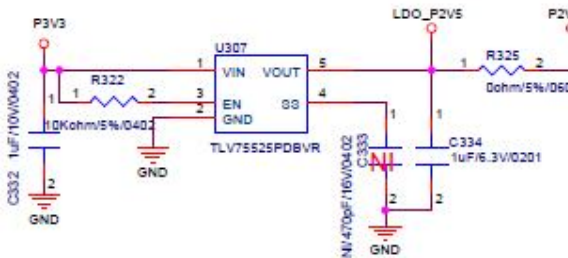
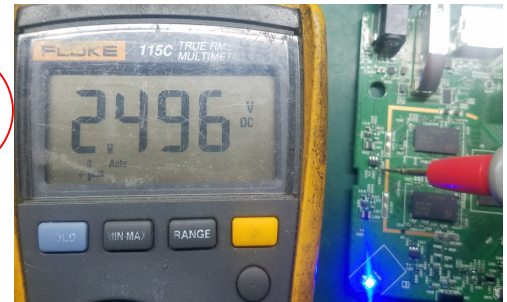
### P3V3 to P2V5

Design Max: 500mA

2.5v

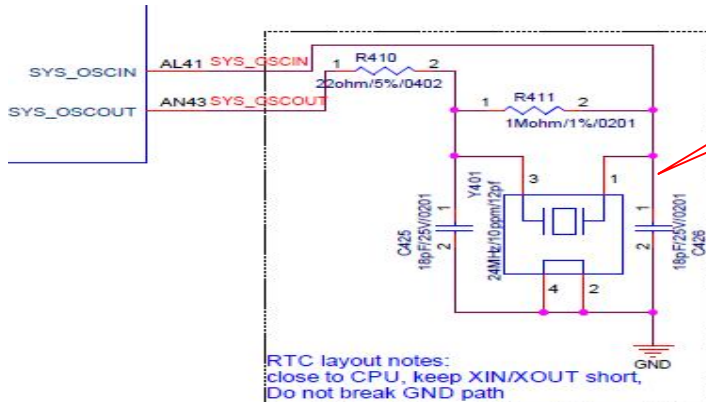
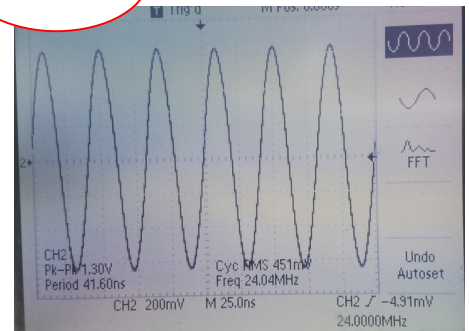
2. No issue was found with system clock:

24MHz

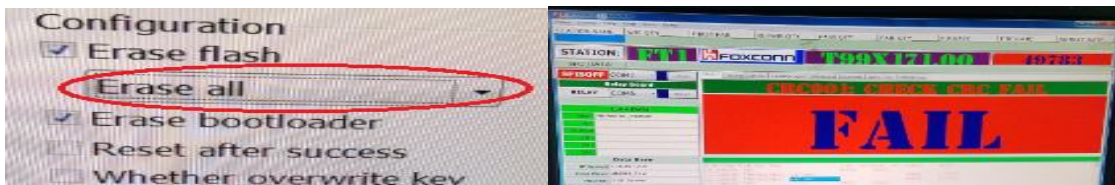
Erase all eMMC data and retest at FT1 → Result: Fail the same (check CRC fail).

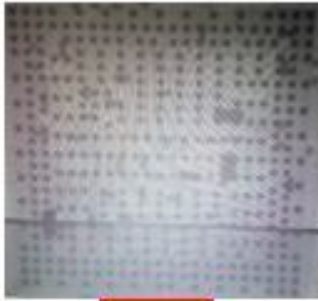
SOC

Nothing abnormal found
