# BFX-UA300 EXCESS&MISSING MATERIAL REPORT

**FOXCONN CPEG JBD\_VN**  
**Sep.-2-2021**  
**Version 02**

# D2. Description of Problems

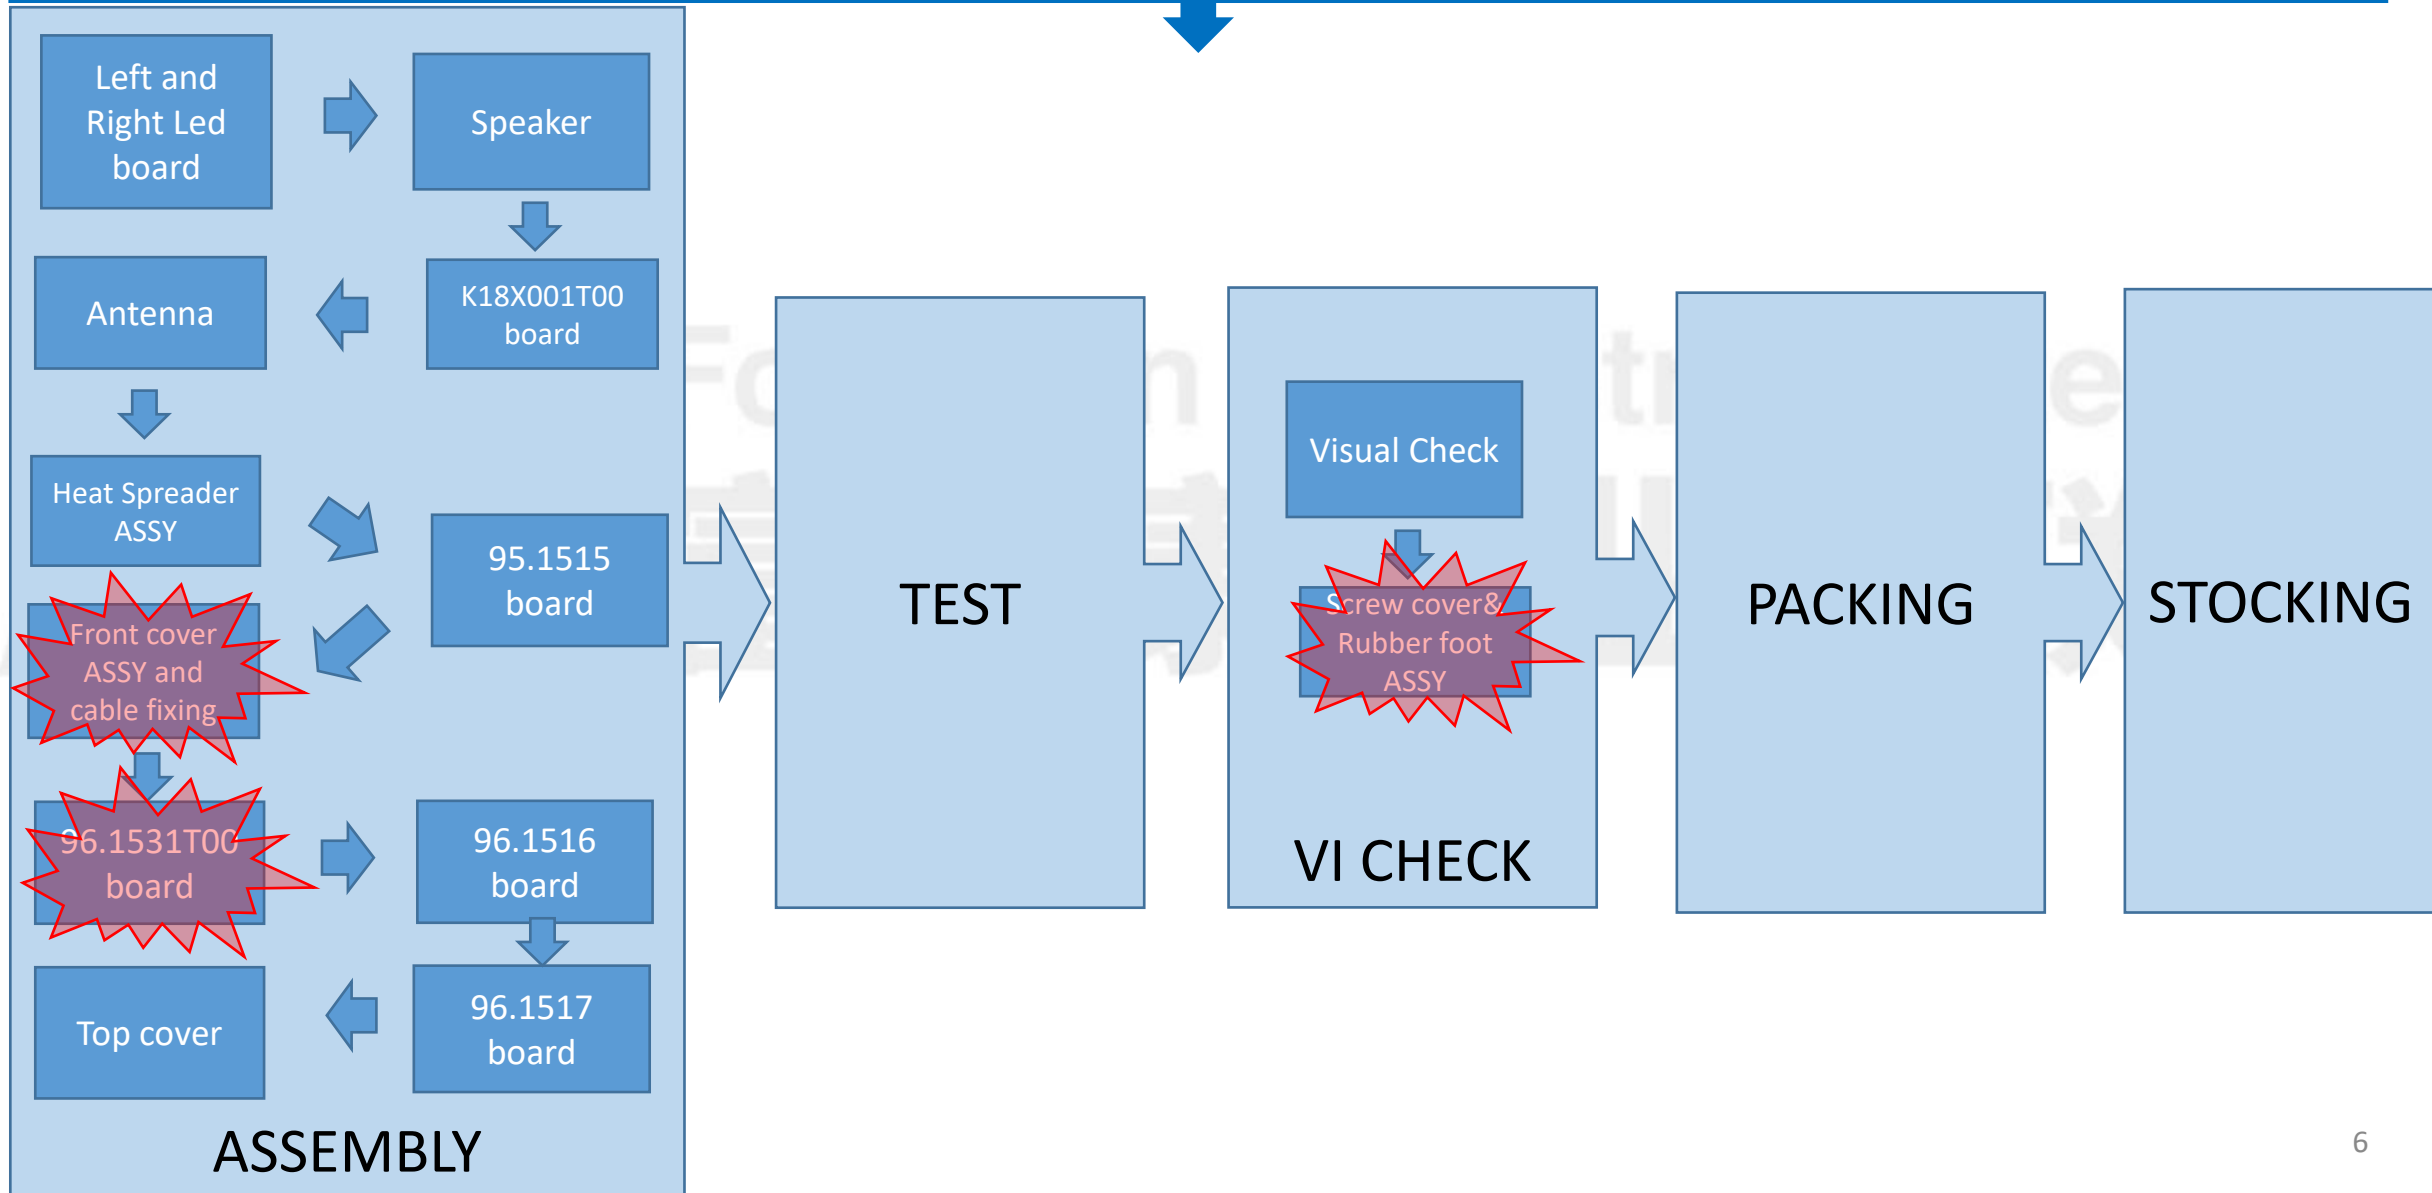
## Check Final Assembly Test process

**Result :** Defect unit have not rework data => All issue happens only in its work step in working process
