# BFX-UA300 Sound Leaked Report

**FOXCONN CPEG JBD\_VN**

**Sep-1-2021**

**Version 02**

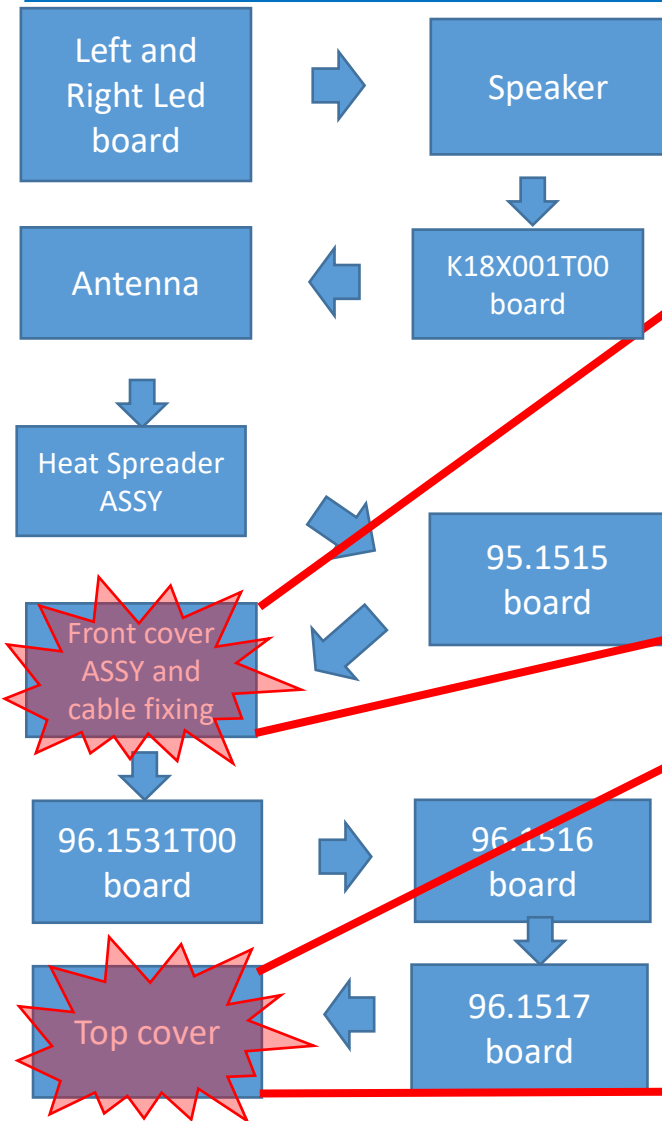
## Check Assembly process

- Conclusion: All defect happen in Assembly stage

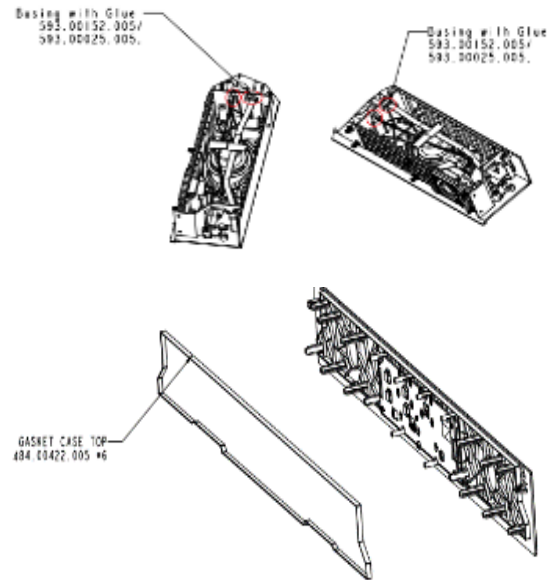
Inner Bushing/Top Gasket Assembly  
in PMD

- Check BFX UA300 Product Manufacture Document of Assembly:  
There are no remark with Adding Top Gasket Method and remark not clearly with Inner Bushing Glue in BFX UA300 Product Manufacture Document

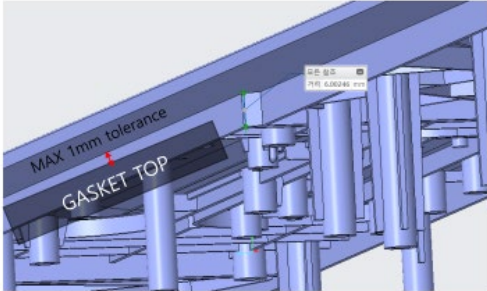
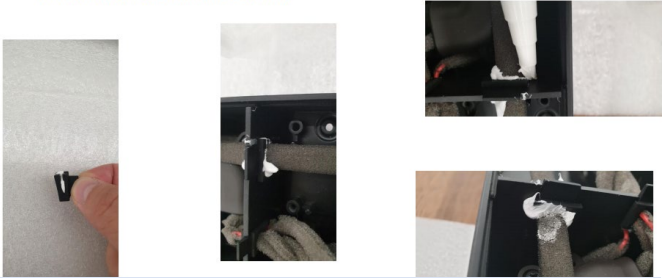
| No. | Subject | Root cause | Corrective action | Evidence | Status | Owner | Due date |
|---|---|---|---|---|---|---|---|
| 1 | Occurrence-Manufacture Document | Operator follow Product Manufacture Document which did not define clearly the glue point/gasket attachment method | <div>1. ALT/RD to update the glue point/ gasket attachment method in Product Manufacture Document.</div> <div>2. Define specs of the glue point and gasket GAP</div> | <div>Gasket<br/>Critical To Quality for Acoustic performance</div> <div>Attachment tolerance : Max +1mm</div> <div></div> <div><div>▲ Glue application method suggestion<br/>To avoid air leakage through the bushing</div><div></div></div> | Done | ALT<br>Fii RD :<br>Jim Chen | 31-Aug |

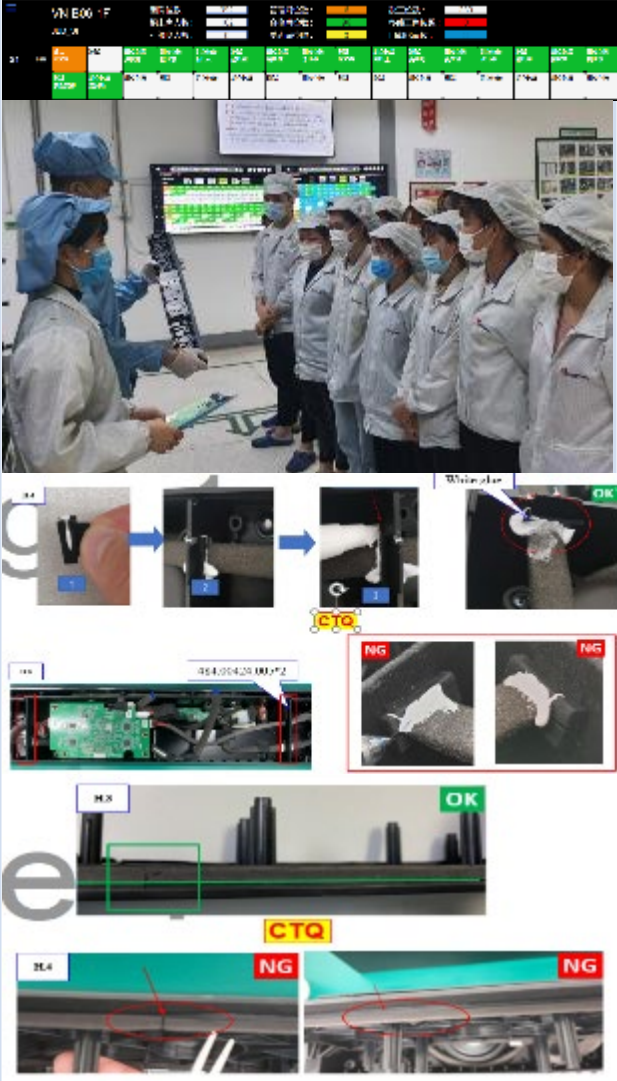
| No. | Subject | Root cause | Corrective action | Evidence | Status | Owner | Due date |
|---|---|---|---|---|---|---|---|
| 2 | Occurrence-Workmanship | <p>1. Operator did wrong when attach gasket on top cover cause intermittent issue</p> <p>2. Cable assembly operator missing one point when adding white glue in Inner bushing</p> | <p>1. Qualified OP are assigned to fixed workstations<br/>→Dedicated operators for dedicated workstations</p> <p>2. Training OP new Assembly method following customer request</p> <p>3. Update this issue in SOP as a CTQ</p> | | Done | <p>SI: Wen Yong</p> <p>PQE: Cheng Da</p> <p>IE: Huyen Trang</p> | 13-Aug |
