# BFX-UA300 FFC cable 8D report

FOXCONN CPEG JBD\_VN  
2022-March-10  
Version 02

## D2. Description of Problems

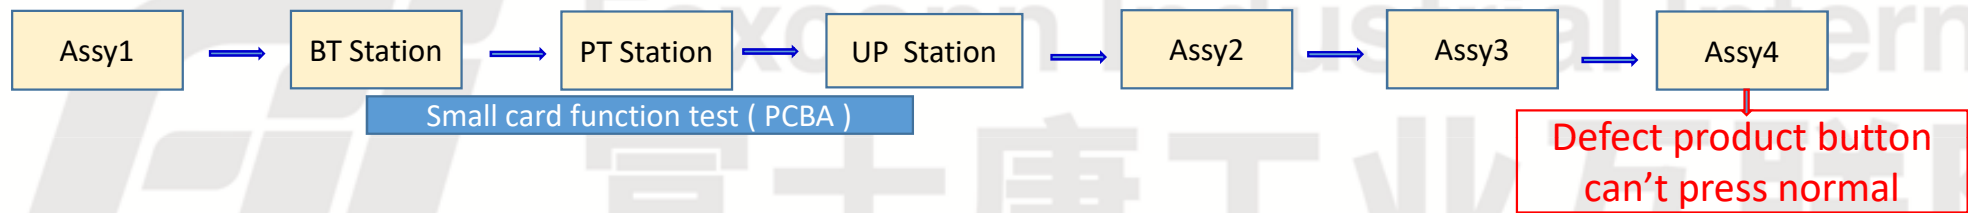
### 7. Production normal process

All normal production control by SFC system from the first station to packing then shipping. Operator doing follow SOP defined

**Summary:** But 2 NG units customer feedback has been rework open housing 2 times. The first time cause button housing issue and 2nd time cause suspect gasket making AMP\_SDA & GND short issue. Rework follow SFC control process , and OP re-assembly and function test follow SOP defined.

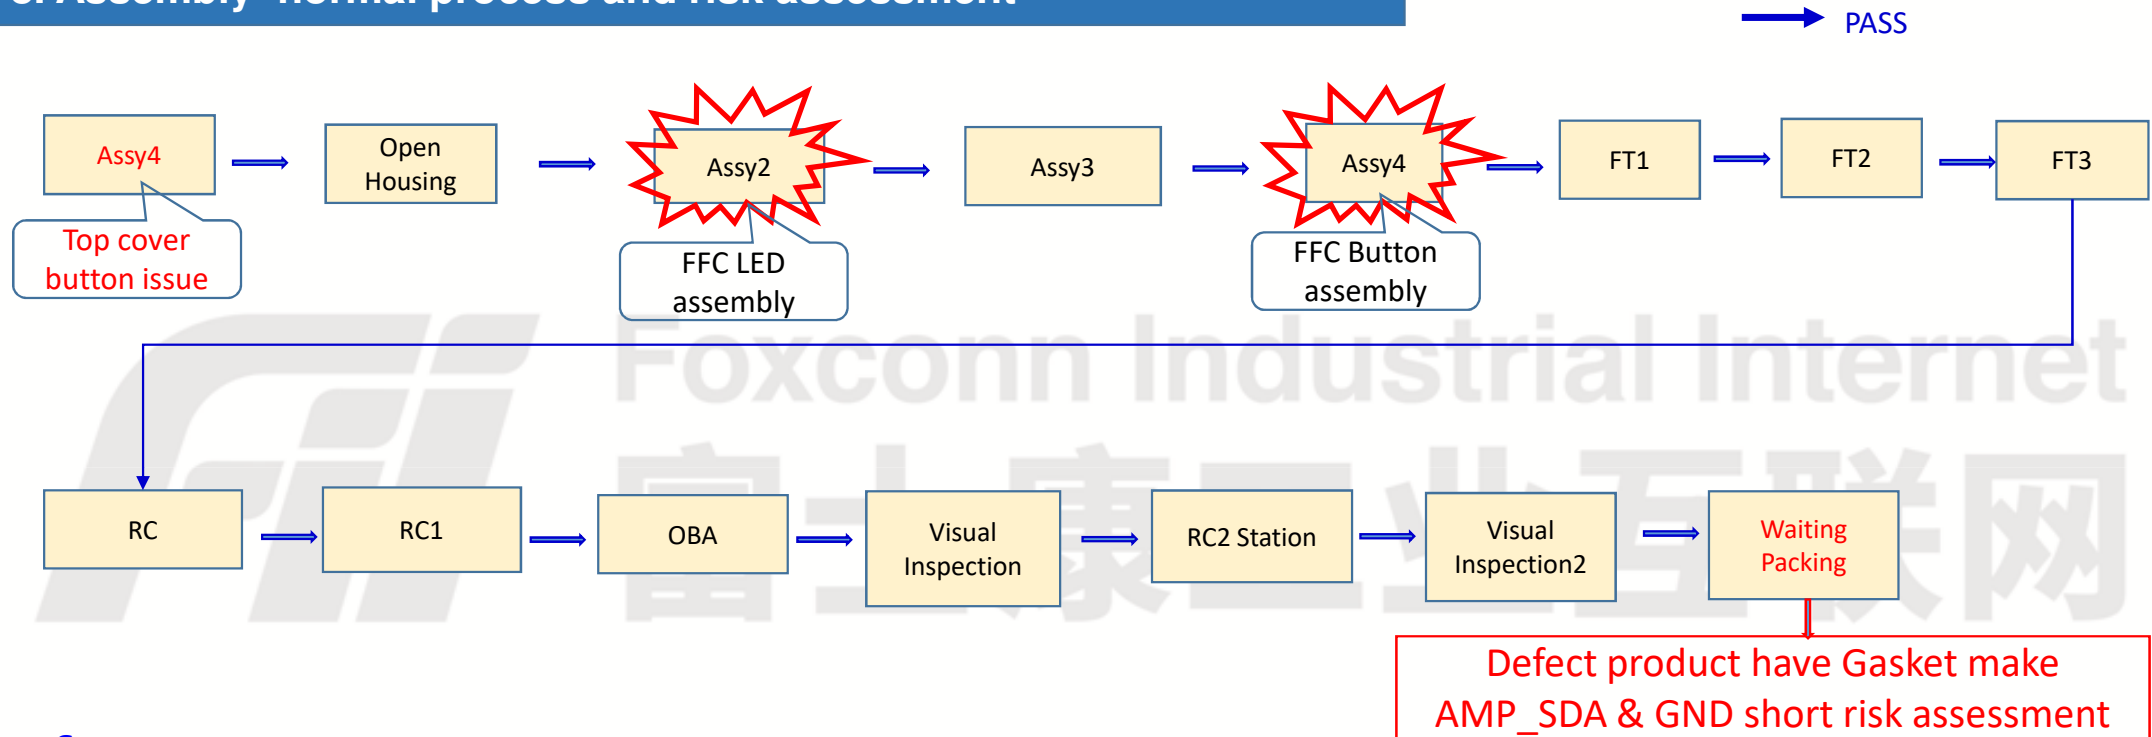
### 8. Assembly normal process and risk assessment

Fii rework the 1<sup>st</sup> time back Assy2 repair housing top cover . After rework housing Top cover , product follow normal process doing to waiting Pack Box station.

That time online product we testing defect some product had gasket making AMP\_SDA & GND short issue. Then we decided rework open housing 2<sup>nd</sup> time for re-check gasket status .

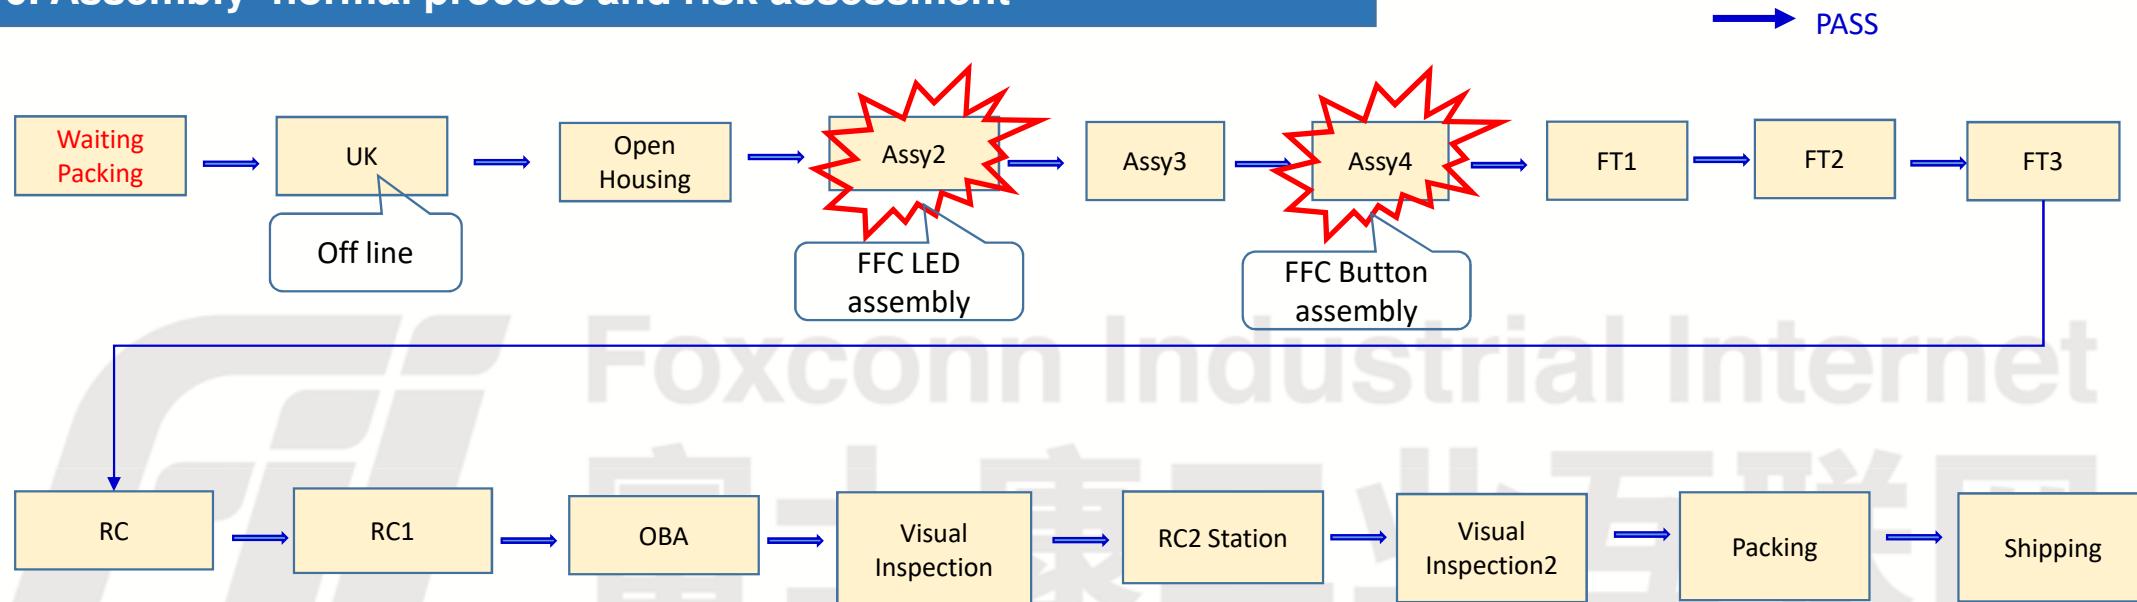
### 10. Assembly normal process and risk assessment

**Summary:** K18X001.00 open housing the 2<sup>nd</sup> times for checking gasket making AMP\_SDA & GND short issue. All rework process control by SFC system, return product back first Assembly station. Doing follow normal process from Assy2 to shipping.

The product doing to final testing station, If want to rework or repair must be re-open housing and take out all main board and FFC cable out of housing. When we re-assembly housing maybe OP input FFC cable head in to LED main board make FFC cable head damage.
