# **BFX-UA300 FFC cable 8D report**

**FOXCONN CPEG JBD\_VN**  
**2022-May-24**  
**Version 06**

# D2. Description of Problems

- 2021-Oct-21, ALT customer complain [BFX-UA300] defect 2 units BFX-AU300  
Symptom : No turn on the LED, No button operation.

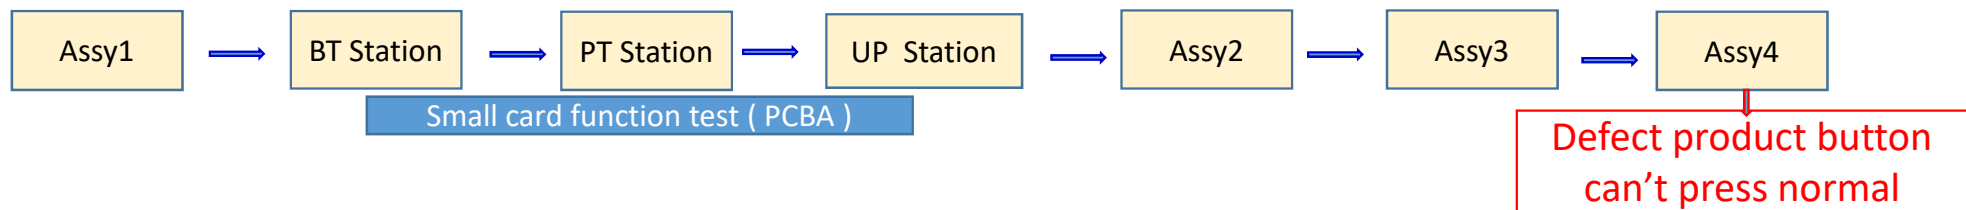
### 7. Production normal process

1. 2 NG units customer feedback has been rework disassembly housing 2 times. The first time cause housing button issue and 2nd time cause suspect gasket making AMP\_SDA & GND short issue.
2. Production line rework the 1st time back Assy2 repair housing top cover . After rework housing Top cover , product follow normal process doing to waiting Pack Box station.

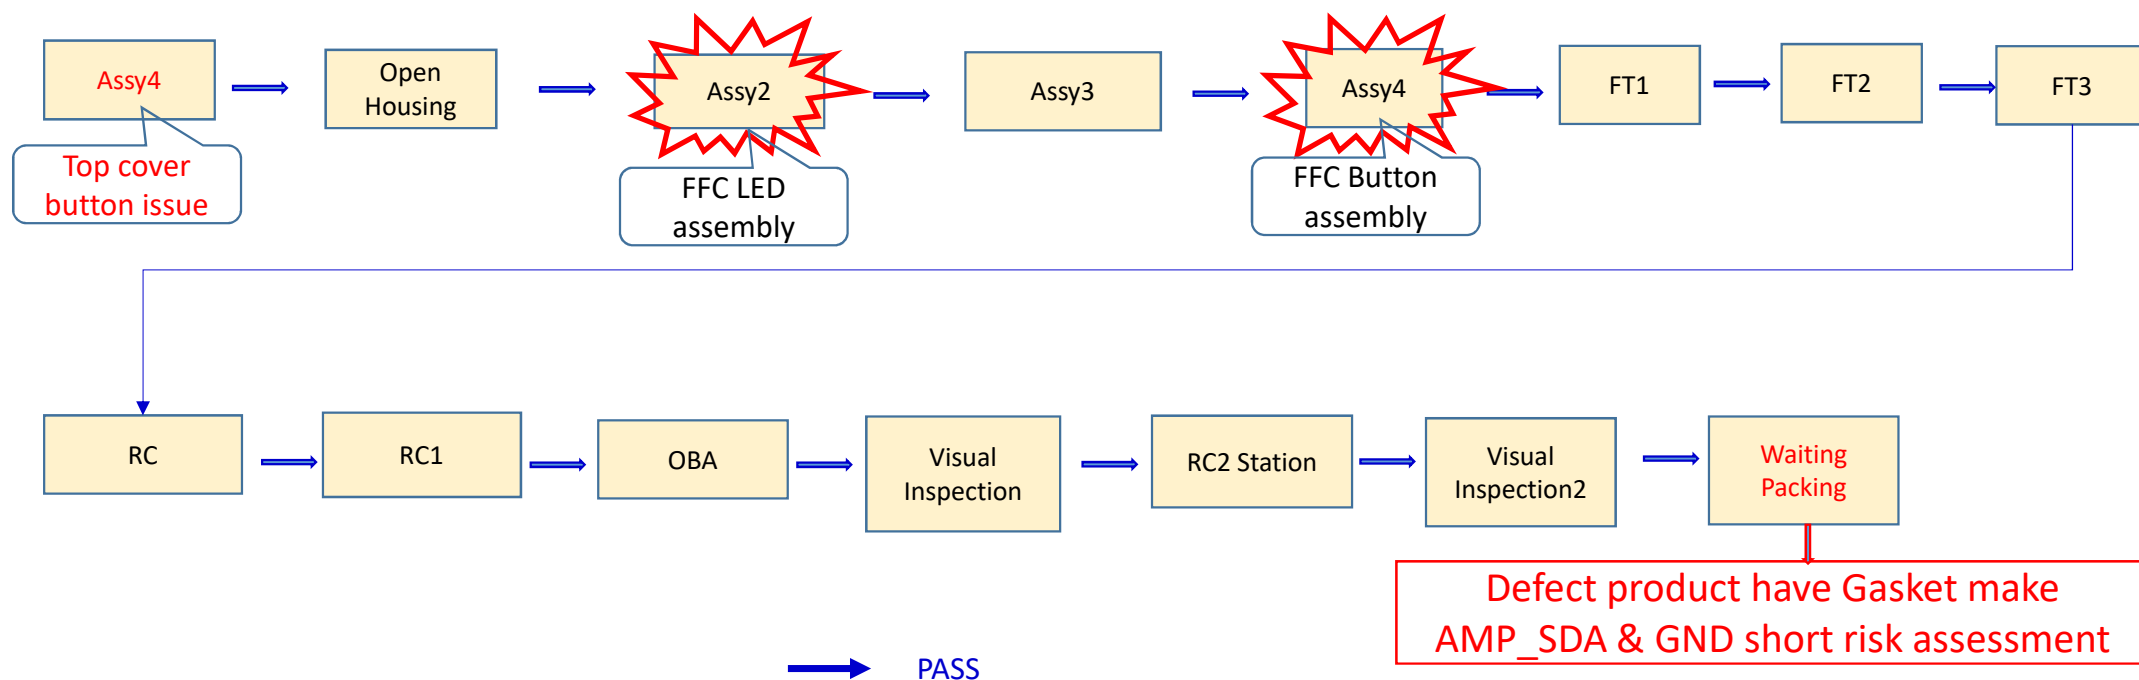
## 8. Assembly normal process and risk assessment

1. Fii rework the 1st time back Assy2 repair housing top cover . After rework housing Top cover , product follow normal process doing to waiting Pack Box station.
2. That time online product we testing defect some product had gasket making AMP\_SDA & GND short issue. Then we decided rework open housing 2nd time for re-check gasket status .

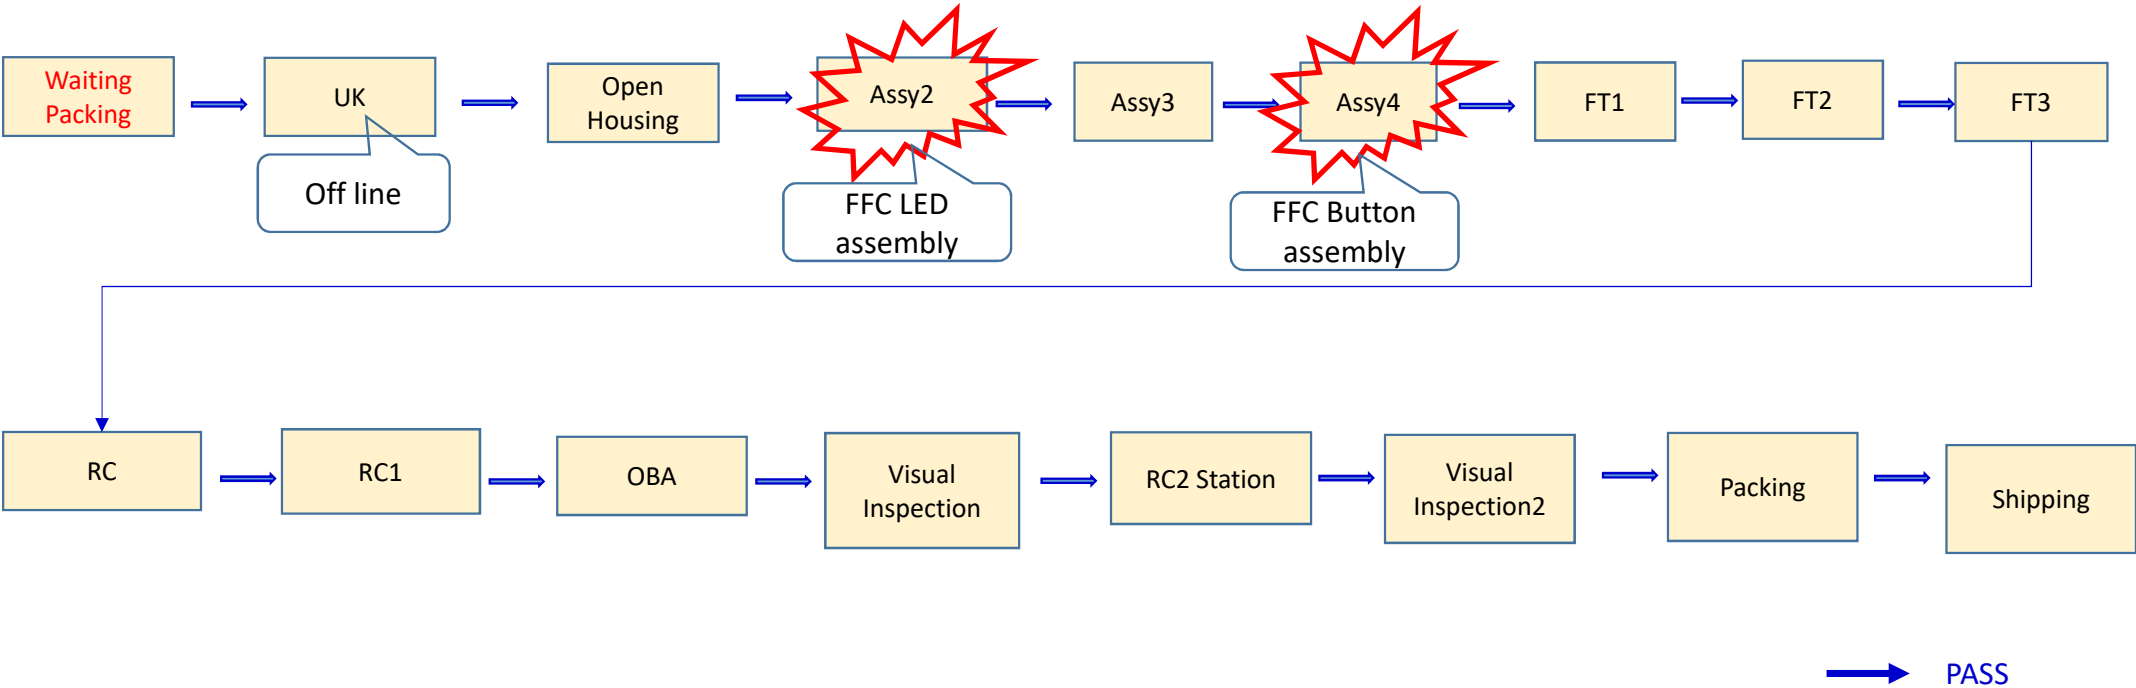
Production line open housing the 2nd times for checking gasket making AMP\_SDA & GND short issue and return product to the first assembly station, disassembly housing one more times.

2. All rework process control by SFC system, Doing follow normal process from Assy2 to shipping.
