## 2022.01 ~03 Mass production inspection

Model Name: BFX-UA300

Document Version: ALT\_STB\_MP\_CSMTINS\_001

Issued Date: 2022.04.08

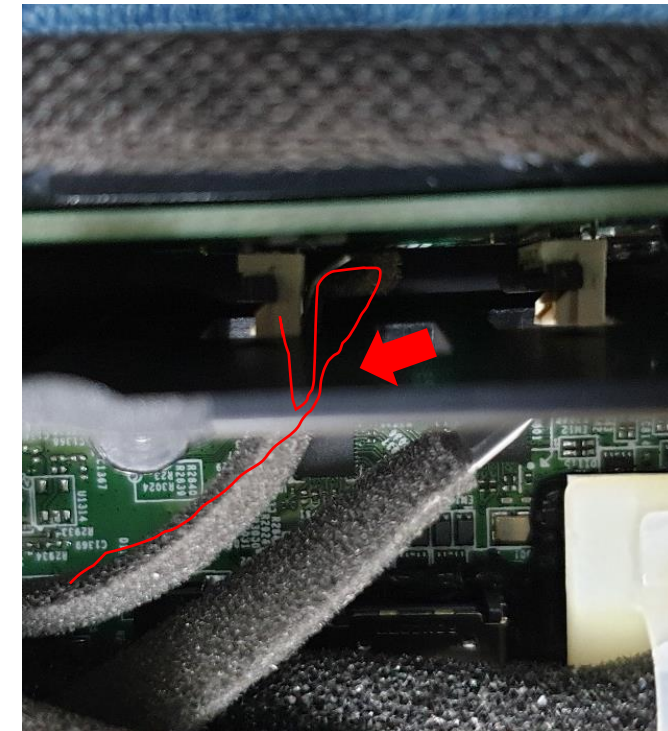
- Inside the screw

- Issue grade : Major

- A noise is heard when the product is shaken (Link)
- Defect unit Q'ty : 1 / 315pcs
- SN : 214969500120202201005431

- Remove the screw

- FXN should be submit 8D report
  - Need to update SOP and WI (Work Instruction)
  - Provide the preventive action – Add product shake test after final assembly
