# **8D Report for ALT STB BFX-UA300 Choke Burned and FFC Cable Melted Issue**

Date : 2022-March-26  
Version: 01

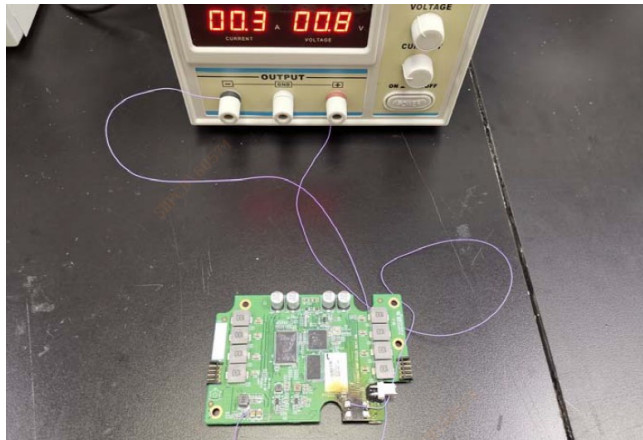
### 3.2 Thermal imaging check – the short location should be in the through hole.

1) energized 0.3A current to A/B circuit , to make the short point hot.

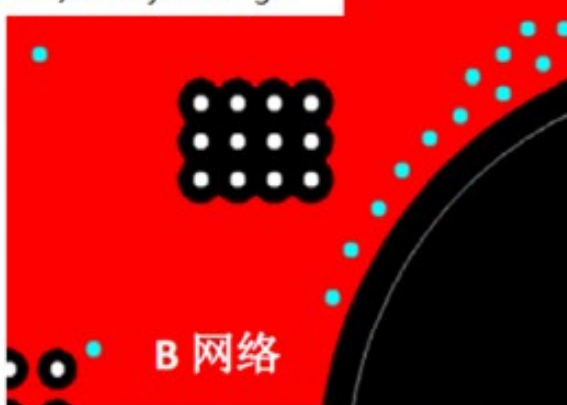
2.2) L2 layer design:

2.1) Observe L2 layer, some melted copper is found around the through hole.

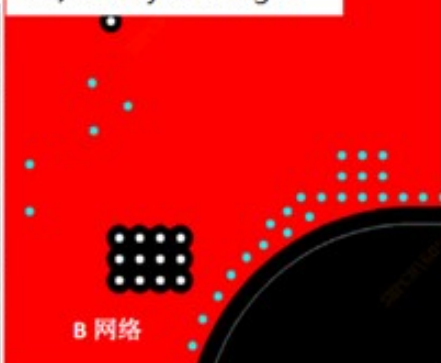
4.2) L3 layer design:

4.1) Observe the L3 layer, no residual copper is found.

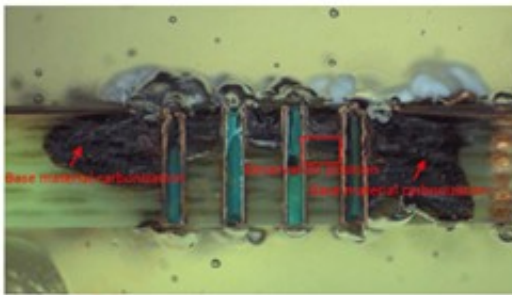
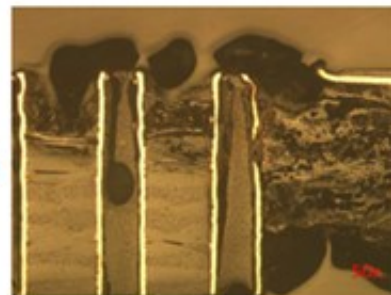
SEM observation:

3.4 SEM observation – the lamination is cracked and melted copper could be found in the crack of the lamination.

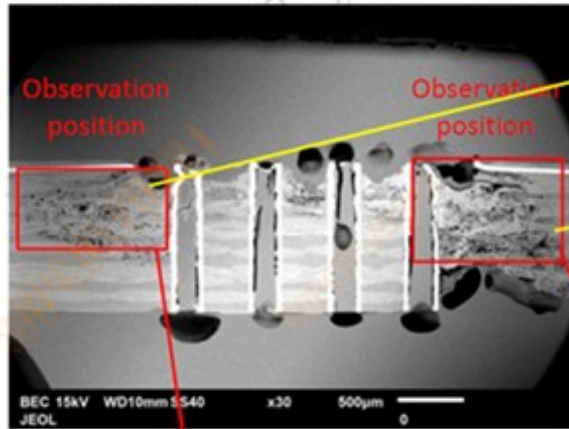
Schematic diagram of section observation

SEM observation summary:  
the lamination is cracked and  
melted copper could be  
found in the crack of the  
lamination.

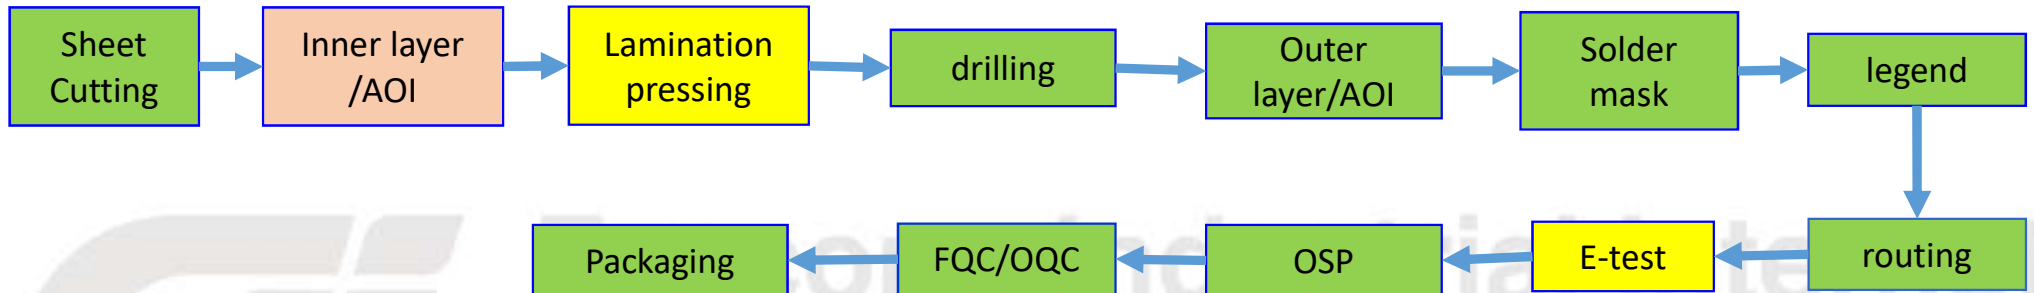
### 5.1 PCB Overall Flow Chart.

From the overall PCB production flow, the possible stations for L2 inner layer short is:

- **Inner layer process** [refer to next page]
- **Lamination pressing station** [Occur] - Residual copper may happen in the Lamination pressing process.
- **E-test station** [Escape] - It can cover the open/short defect.

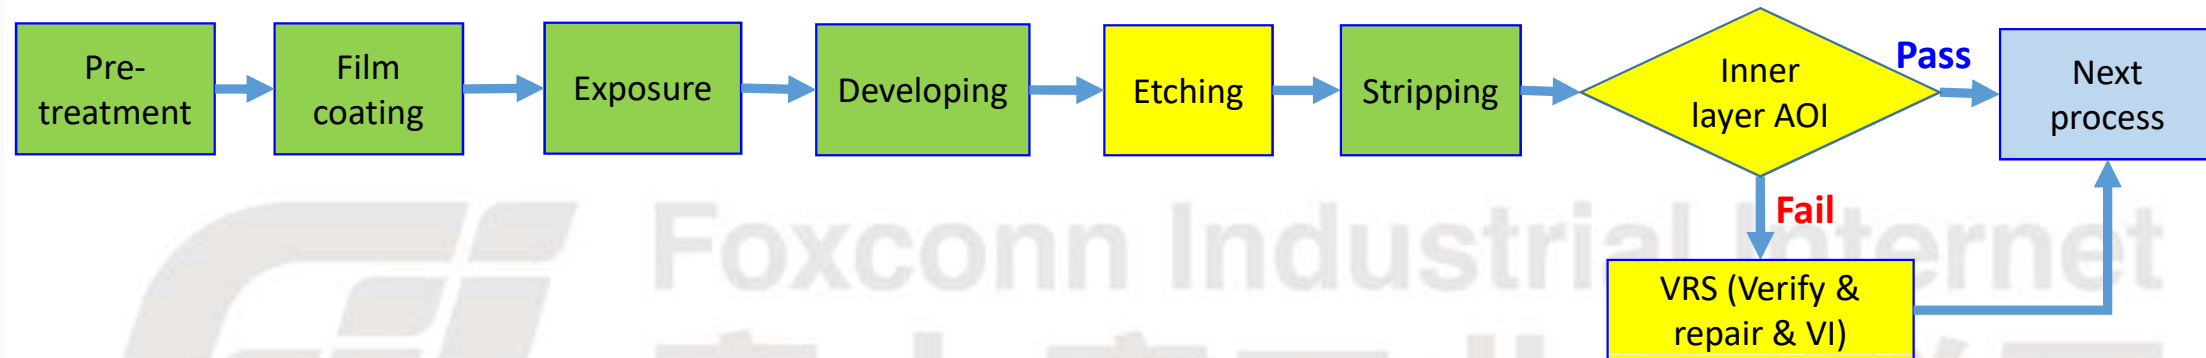
### 5.2 L2 Inner layer flow chart

From the L2 inner layer flow, the possible stations for L2 inner layer short is:

- **Etching station** [Occur] - Residual copper in the inner layer may happen in the etching process.
- **Inner layer AOI station** [Escape] - AOI can cover the short defect, but it maybe bypass by AOI operator.
- **VRS station** [Escape] - Only visual inspection the repaired PCB, it's better to retest AOI.

1. Optimize the VRS process, repaired PCB must 100% AOI. Implement D/C 2212.
