# New AMP b/d+DVT2 Main Board Rework SOP

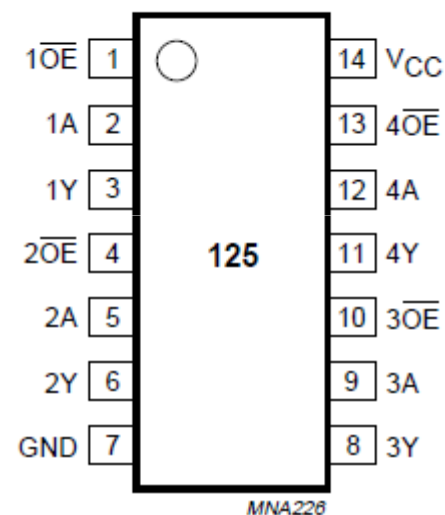
### Figure 7: Pin define of 74LVC125APW

- If I2S bus has output gap issue of AMP board, PLS add a buffer IC (74LVC125APW) near J814.
