# 8D Report

**for cosmetic issue of BFX - AT100 (T99X171)**

Date : 15 November 2019

**1 November 2019, ALT customer complain [BFX-AT100] 3rd Mass production  
Cosmetic issue.**

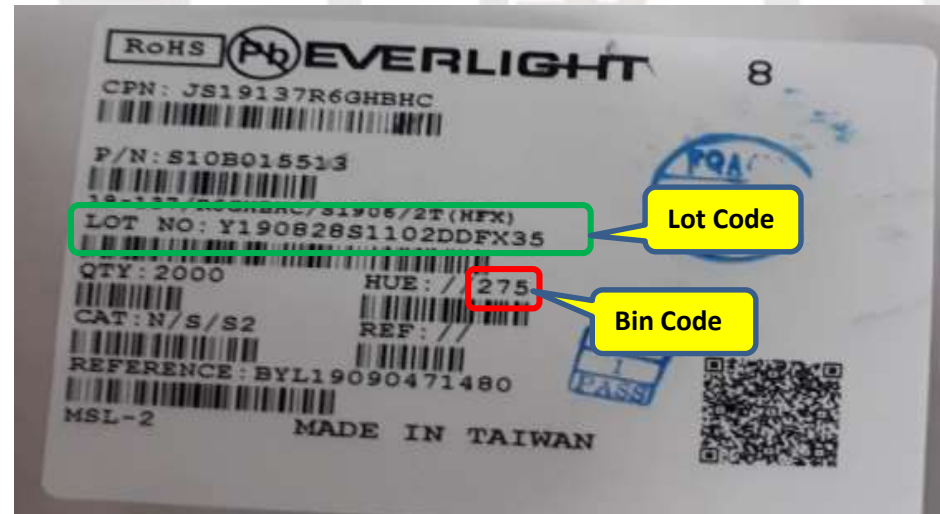
This defect is belongs to bin code PW05 [in specification](#) with reddish color. Please see detail in corrective action page 31, 32.

5.4.3. Required vendor add bin code information in Lot code in order to IQC upload to system for controlling. We will separate Lot code with PW05 bin code to run a MO and monitor if have any LED reddish color over specification and then send to vendor analysis and improve (as picture below)

Owener: RD/SQE: Sean Chiang, Tony Trinh Due date: 17 January 2020
