## 8D REPORT

| 機種<br>Model | 19-137/R6GHBHC/S1906/2T(HFX) | 批號<br>Lot number | NA |
| 料號<br>Part number | S10B015513 | 批量<br>Lot size | NA |
| 客戶反應問題<br>Custom's Complaint | Color shift | | |

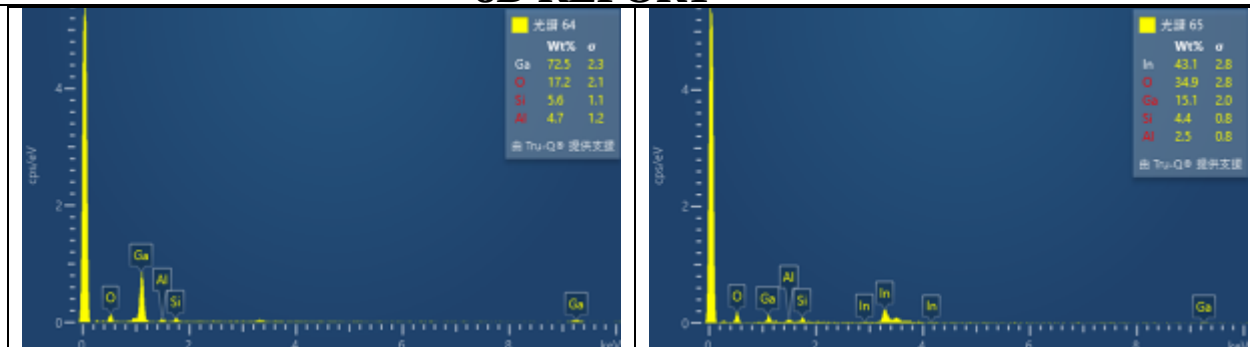
6691

The adhesion material around the wafer surface was observed by SEM.

According to the results of EDX, the short circuit was caused by the adhesion of silver glue to the P/N Junction on the wafer surface.

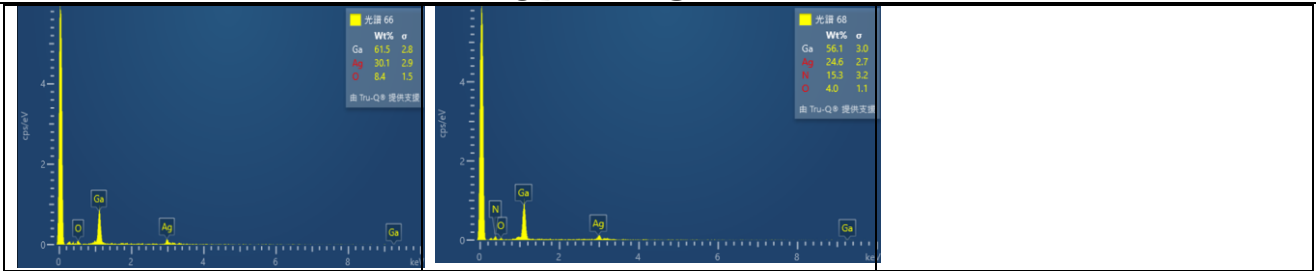
6806:

The 6806 cannot be measured because of the shift of wafer after DE-CAP/the broken wire by mistake.

The adhesion material around the wafer surface was observed by SEM.

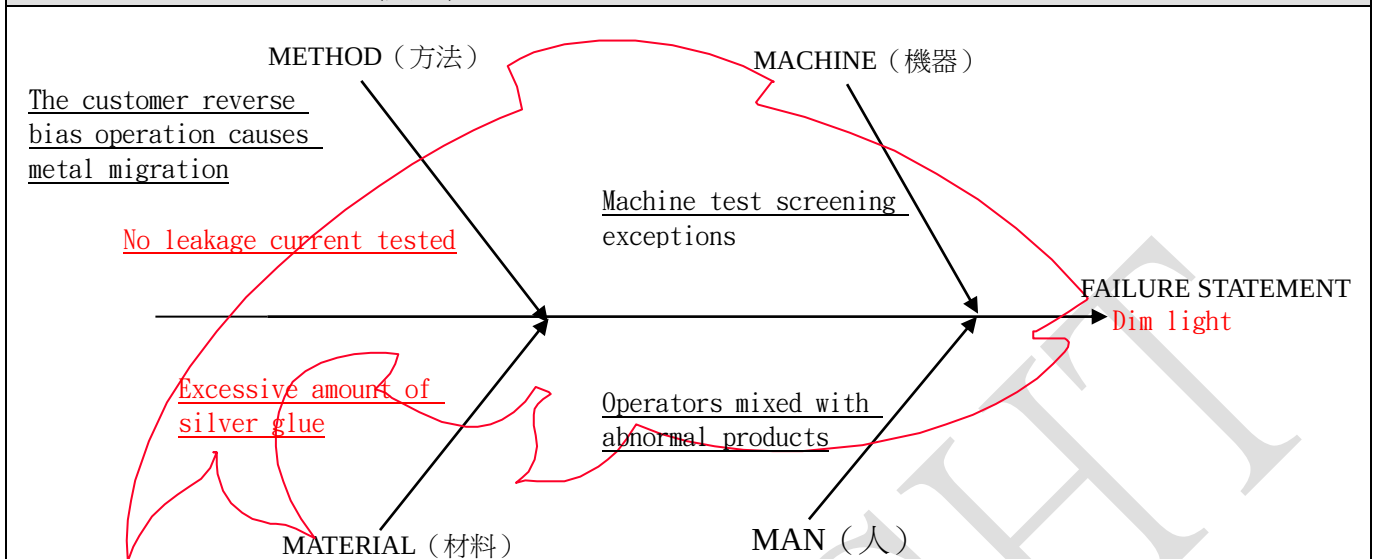
Cause: The possible reason is that the volume of solder paste is higher, and it close with the P/N Junction area causing a small leakage current condition.

Reason of outflow: The product has an Zener diode. The leakage current of the chip end cannot be tested during the electrical test in the factory, resulting in such abnormal loss.

On-line screening of abnormal materials - Zener gold wire pick out - measuring whether there is leakage current RGB chip.

Change the cleaning frequency of glue-stained pin to clean the glue needle after glue-stained 15K.
