# FAILURE ANALYSIS REPORT

## ( KLM8G1GETF-B041 )

For: FOXCONN TECHNOLOGY CO., LTD-TW

May 21, 2024

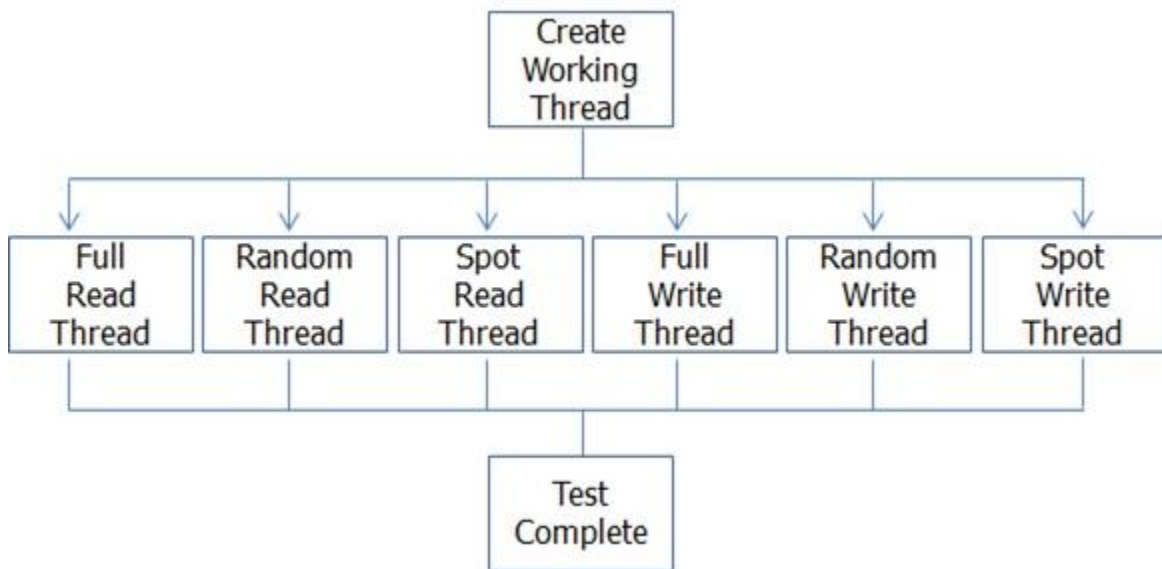
Test conditions are as below.

[Test Flow]

As a result, device had passed an additional test without any failure symptoms.
