## AMP FFC and Common mode Filter is malting issue

Model Name: BFX-UA300

Document Version: ALT\_STB\_MP\_CSMTINS\_001

Issued Date: 2022.02.08

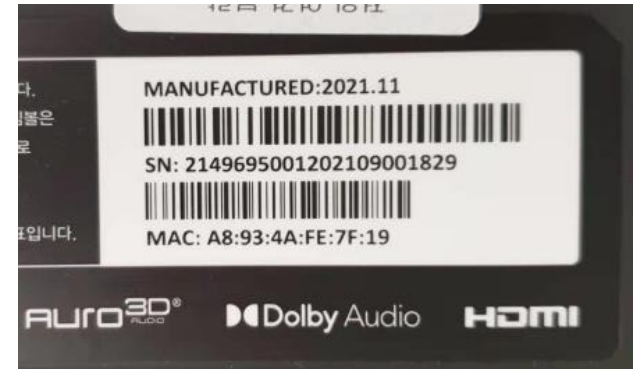
- AMP FFC and Common mode Filter is malted

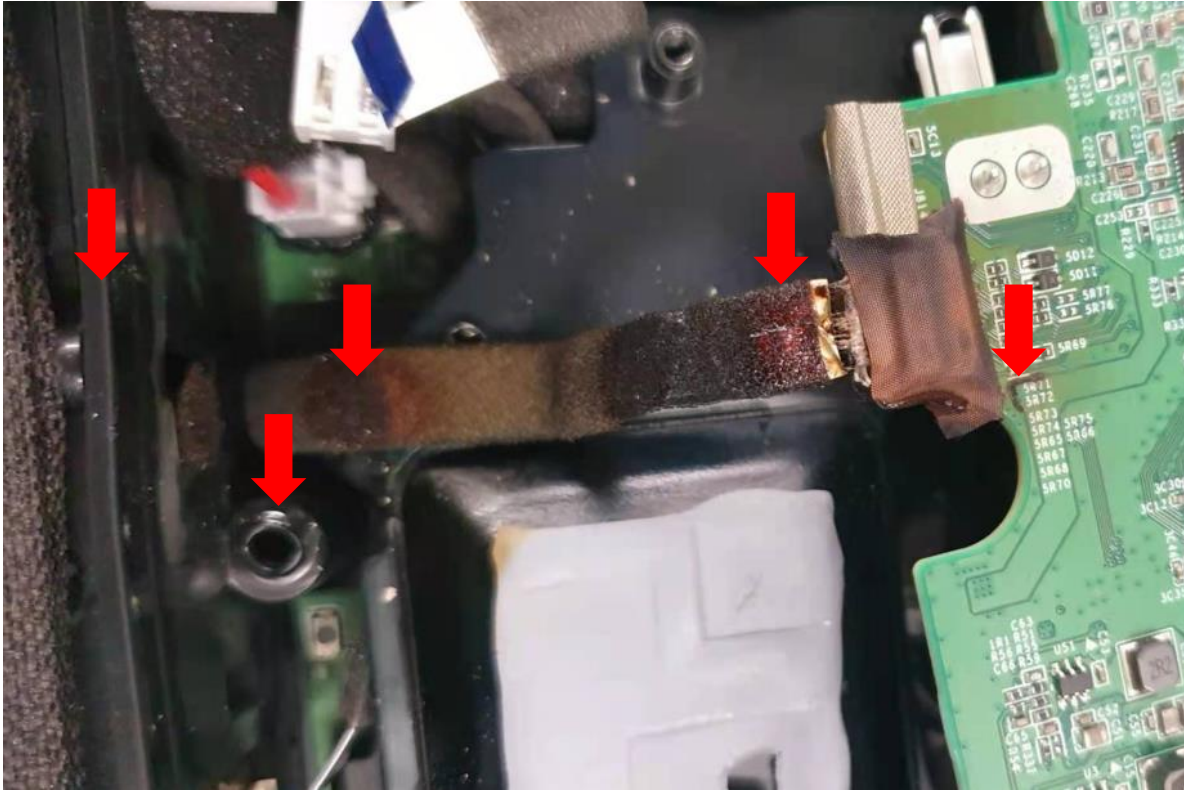
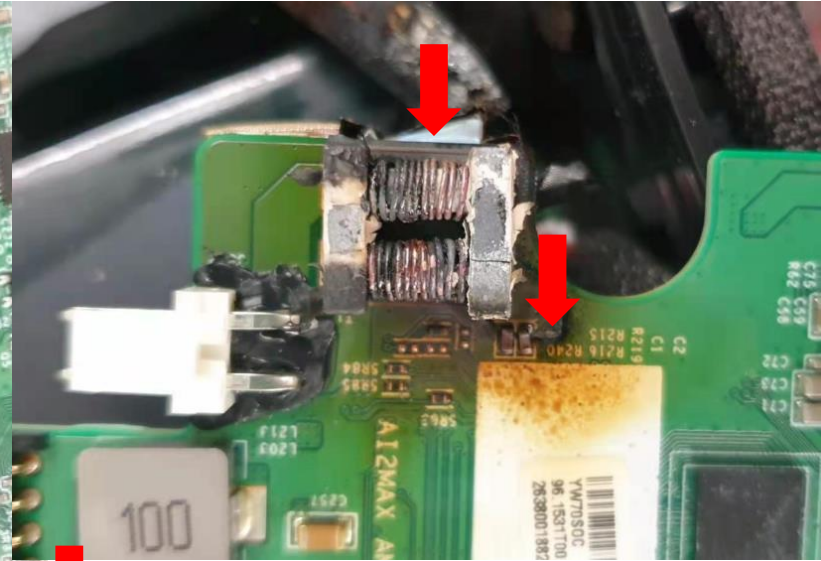
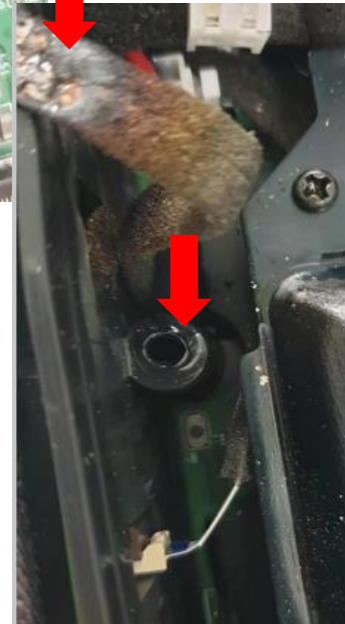
- AMP FFC and Common mode Filter is melted
  - Issue grade : Critical
  - Symptom : No Power
  - ALT initial review
    - Disassembly Top cover, almost melted Amp FFC cable
    - The Common mode filter is also melted
    - The Bottom housing deformation started due to heat
      - > See the next image
    - It proceeded until just before the fire of the product
  - FII Action item
    - analyze the root cause ASAP base.
    - FXN should be submit 8D report
      - Make short term solution and apply immediately
      - Make long term solution and verification with ALT
