## Cross section Test report review

Model Name: BFX-UA300

Document Version: ALT\_STB\_MP\_CSMTINS\_001

Issued Date: 2022.08.12

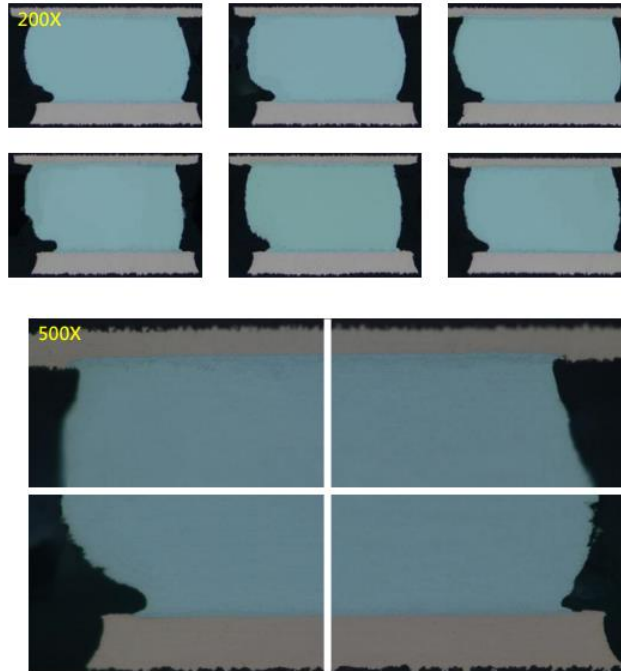
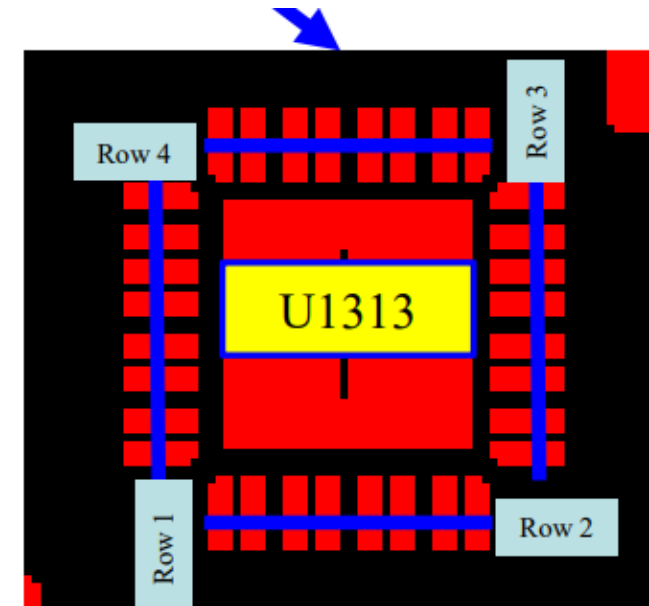
ROW 1

U1: All the solder joints show good wetting .The representative photos are shown as below.

- Almost inspected BGA looks like solder crack
  - Update all of Row picture and pin number : U1 and U1313
  - Report has only 6 point section result for each row
  - Please attaches the high resolution image file also
