# Reliability Test Report for

## BFX-AT100

### (Short term solution LED)

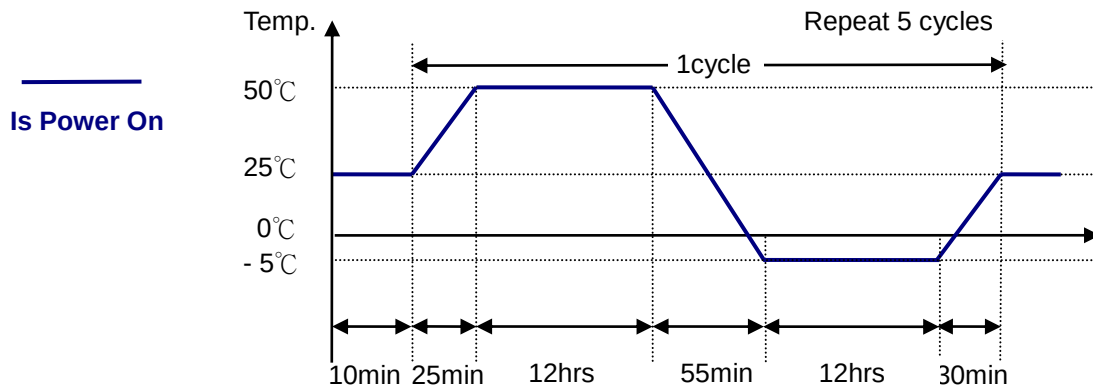
### Test Profile:

1. Power on, then activated in full function and operation.
2. Start test at 25°C for 10 min.
3. Ramp the temperature to 50°C for 12 hours.
4. Ramp the temperature to - 5°C for 12 hours.
5. Repeat item 3 ~ 4 for 5 cycles.

**Basis for Profile:** IEC 60068-2-30.

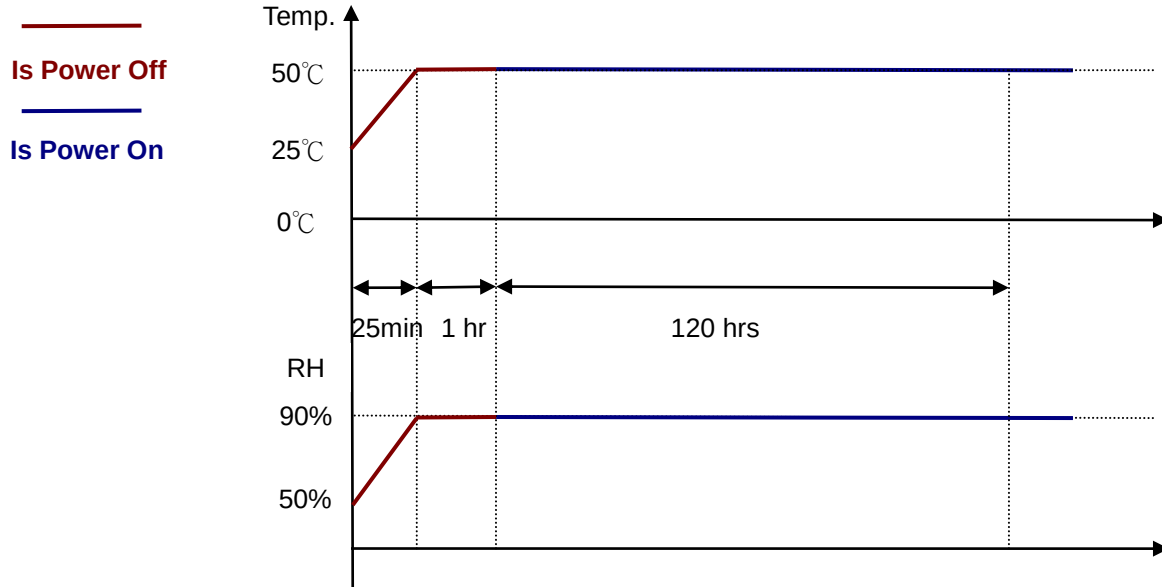
### Test Profile:

1. Power off.
2. Start test at 25°C and RH 50%.
3. Ramp the temperature to 50°C and RH 90% in 25 minutes, then hold for 1 hour.
4. Power on the test units.
5. Hold 50°C, RH 90% for 120 hours.

**Basis for Profile:** MIL-STD-202F Method 103B

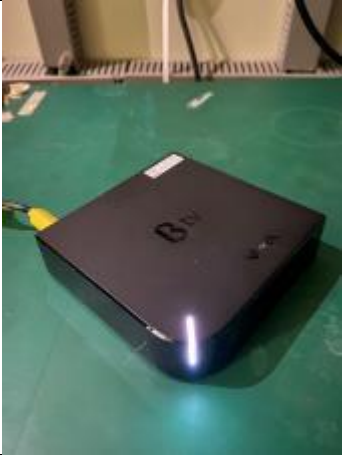
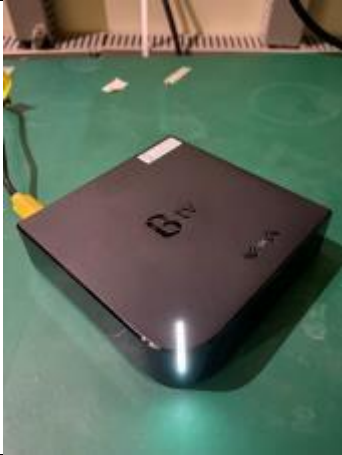
| No. | SN | Before | After | Result |
|---|---|---|---|---|
| 1 | 214968810000000000000002 | | | Visually no abnormalities |

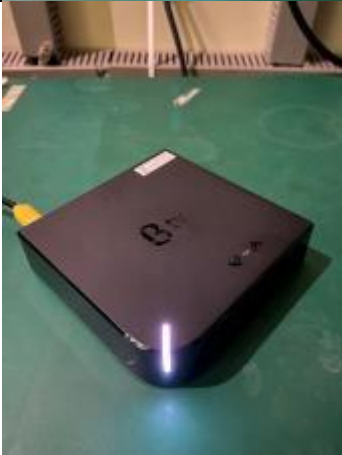
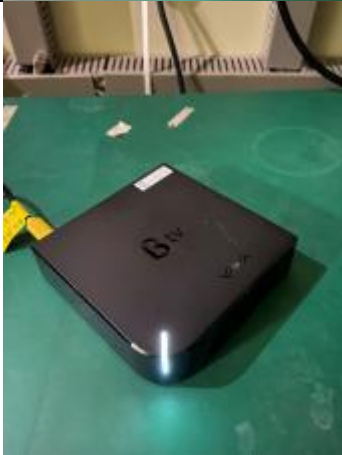
| No. | SN | Before | After | Result |
|---|---|---|---|---|
| 2 | 214968810000000000000003 | | | Visually no abnormalities |

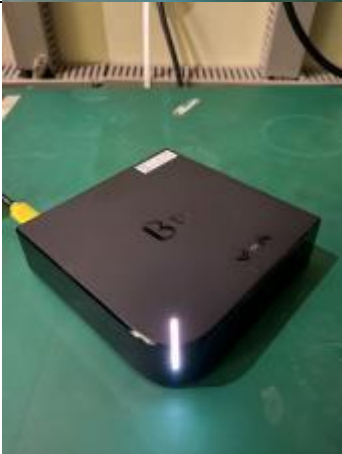
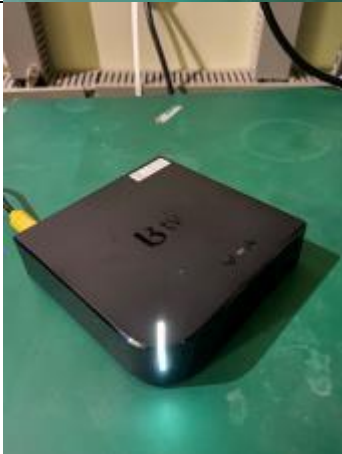
| No. | SN | Before | After | Result |
|---|---|---|---|---|
| 3 | 214968810000000000000001 | | | Visually no abnormalities |

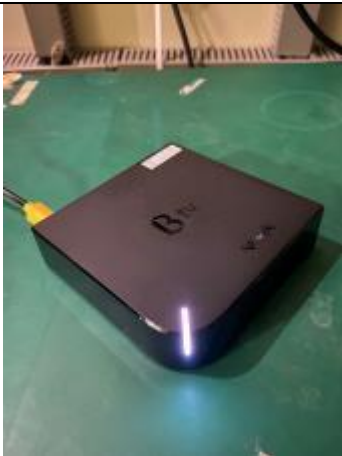
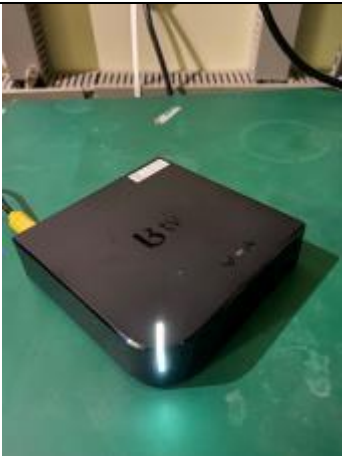
| No. | SN | Before | After | Result |
|---|---|---|---|---|
| 1 | 2149688100000000000014 | | | Visually no abnormalities |

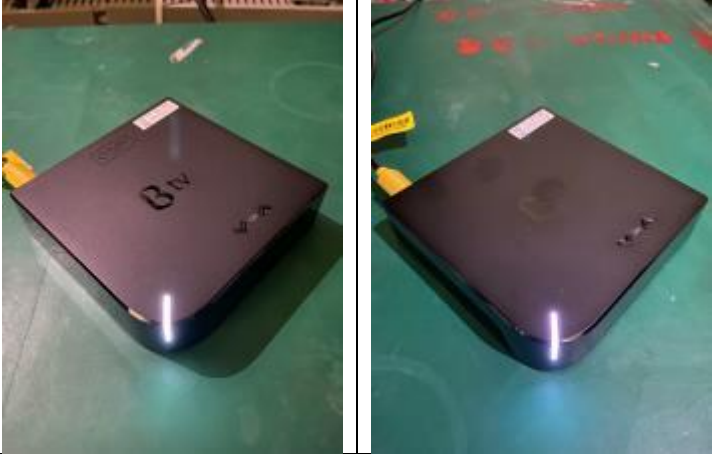
| 20 | 21496881000000000000021 | | Visually no abnormalities |
